# **Environmental Management Report Pakenham Quarry**

For period 14<sup>th</sup> February 2009 – 14<sup>th</sup> March 2008

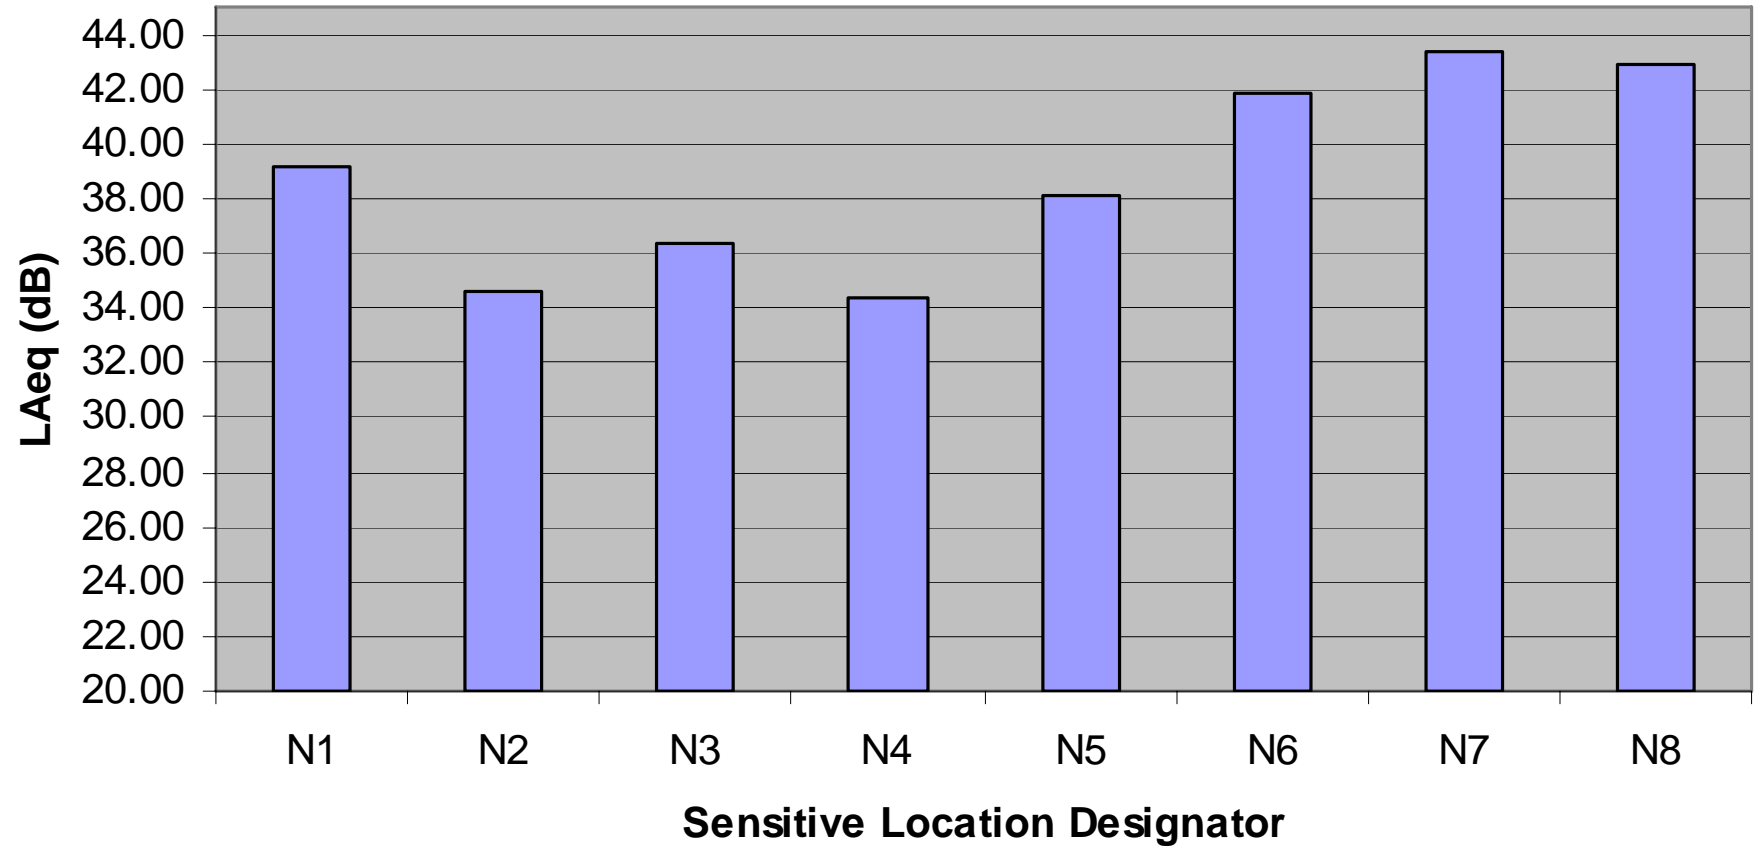
Figure1.1 Average Daily Values for Noise Monitoring of Sensitive Locations

All locations returned LAeq levels lower than the standards set out in *Mt Shamrock Quarry Environmental Management Plan Version 1: 18 January 2008*. At the date of this report there had been no complaints in relation to operating noise and therefore no noise level monitoring at a complainant's residence. Refer to Figure 1.1

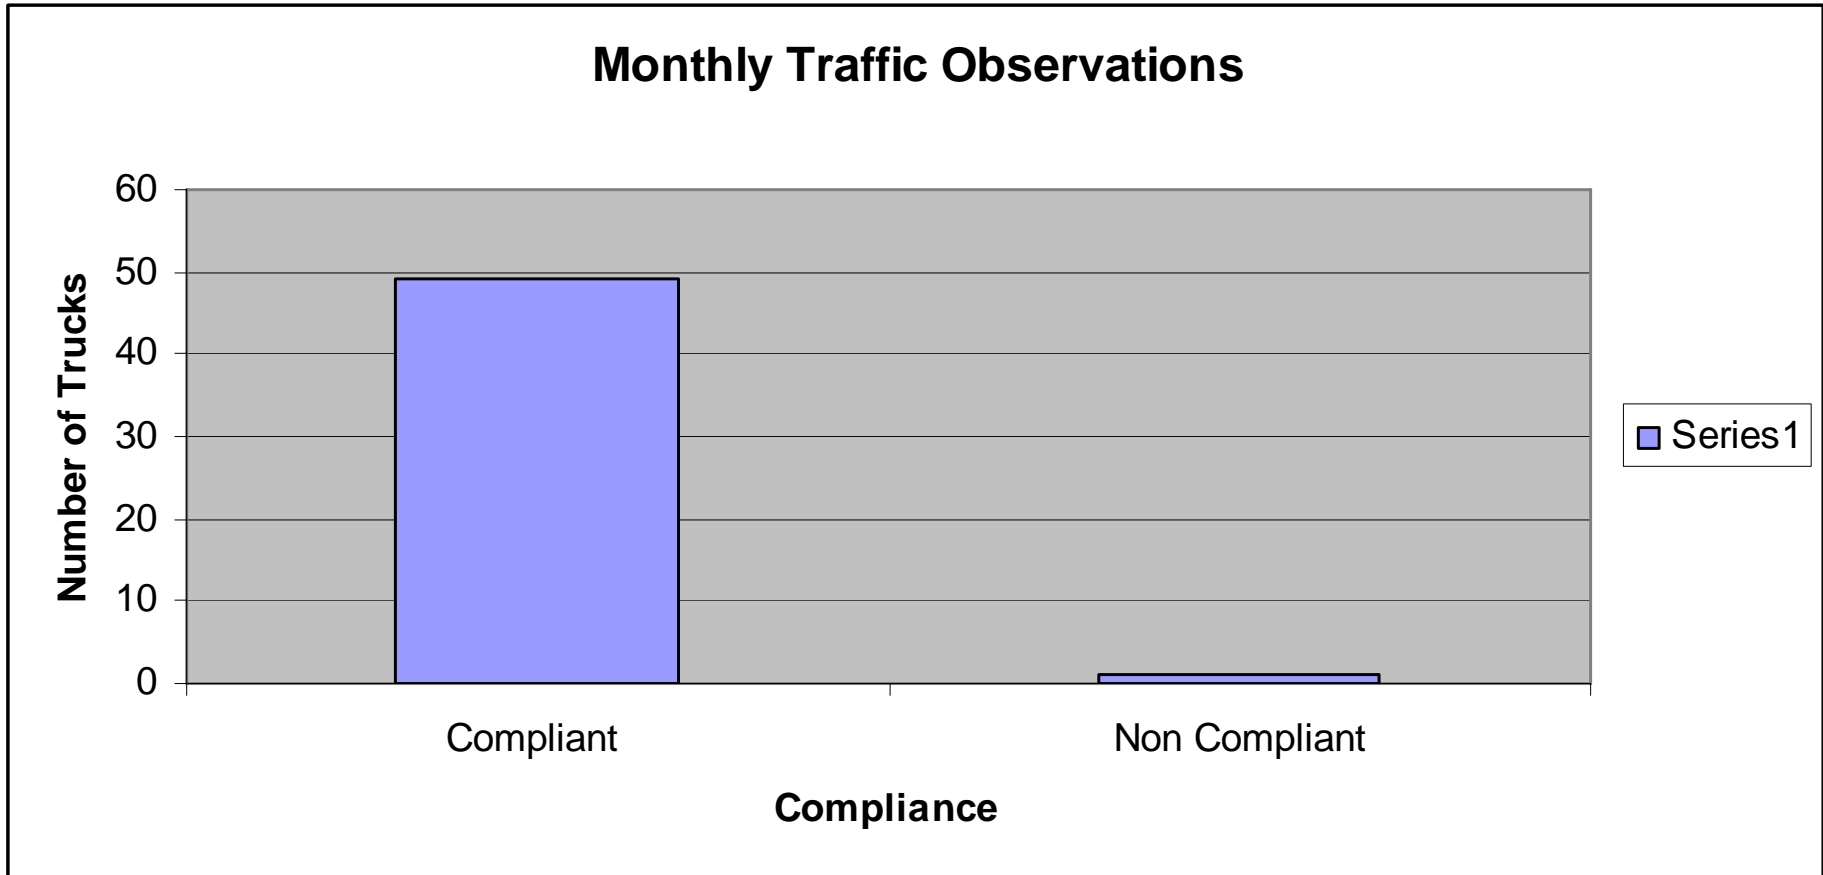
Figure 1.4: Traffic observations for reporting period

Evaluation of trucks leaving the site concluded that there is minimal material being tracked onto public roadways, all loads for the month were covered and correctly loaded. Trucks that were non-compliant were informed and advised that continued non-compliance may result in disciplinary action. Refer Figure 1.4
