# **Environmental Management Report Pakenham Quarry**

For period 14<sup>th</sup> January 2009 – 14<sup>th</sup> February 2008

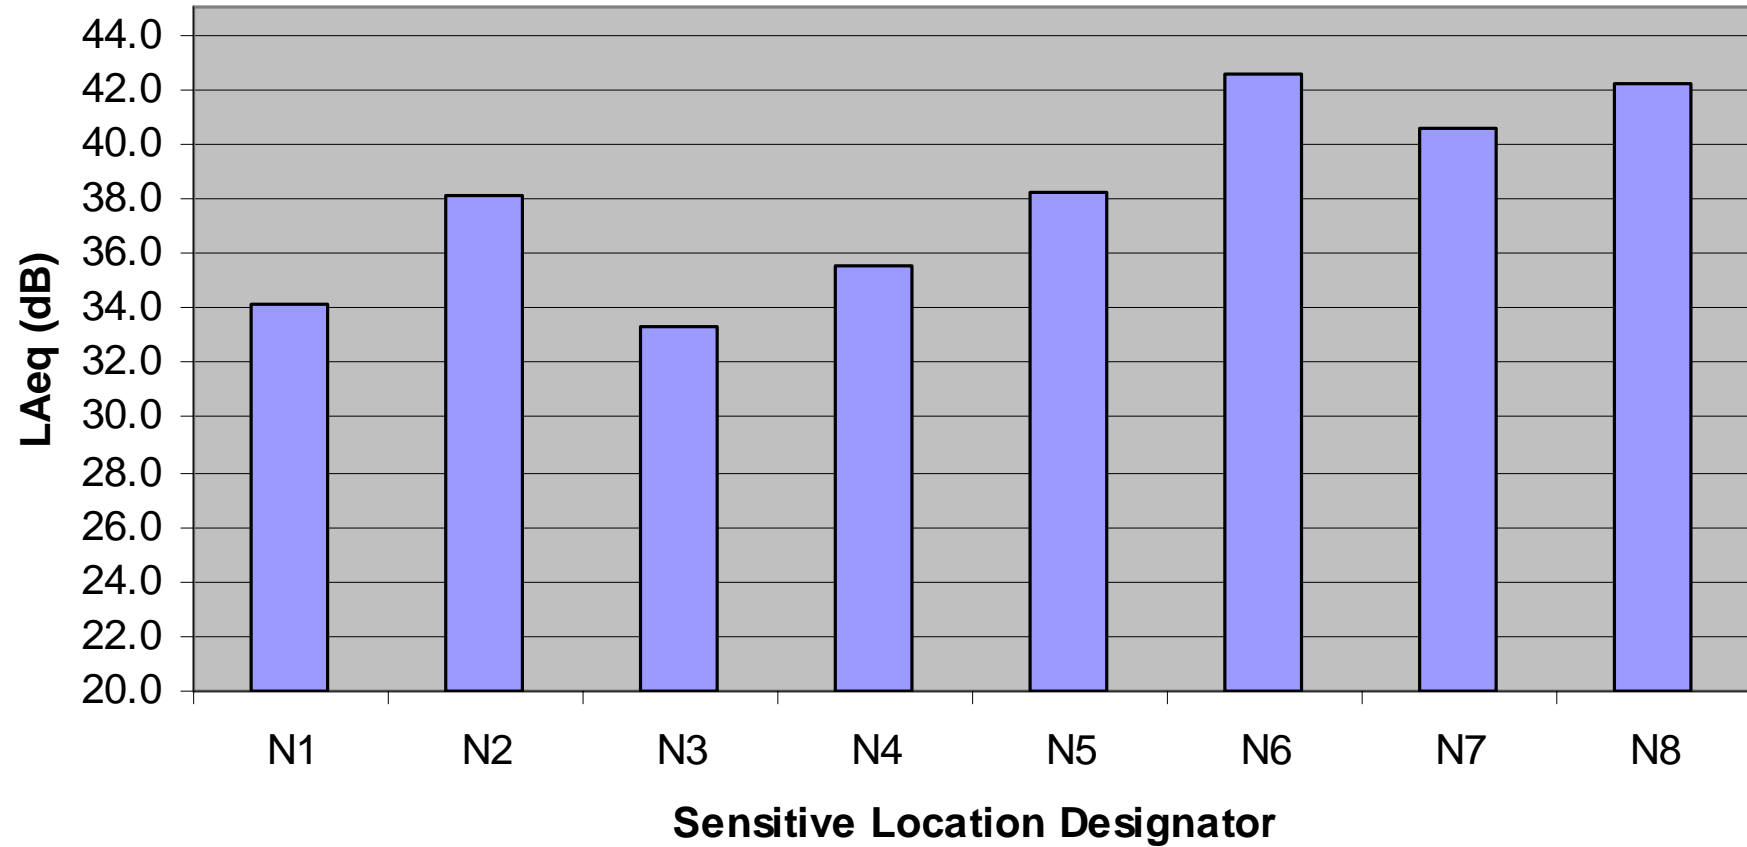
Figure1.1 Average Daily Values for Noise Monitoring of Sensitive Locations

All locations returned LAeq levels lower than the standards set out in *Mt Shamrock Quarry Environmental Management Plan Version 1: 18 January 2008*. At the date of this report there had been no complaints in relation to operating noise and therefore no noise level monitoring at a complainant's residence. Refer to Figure 1.1

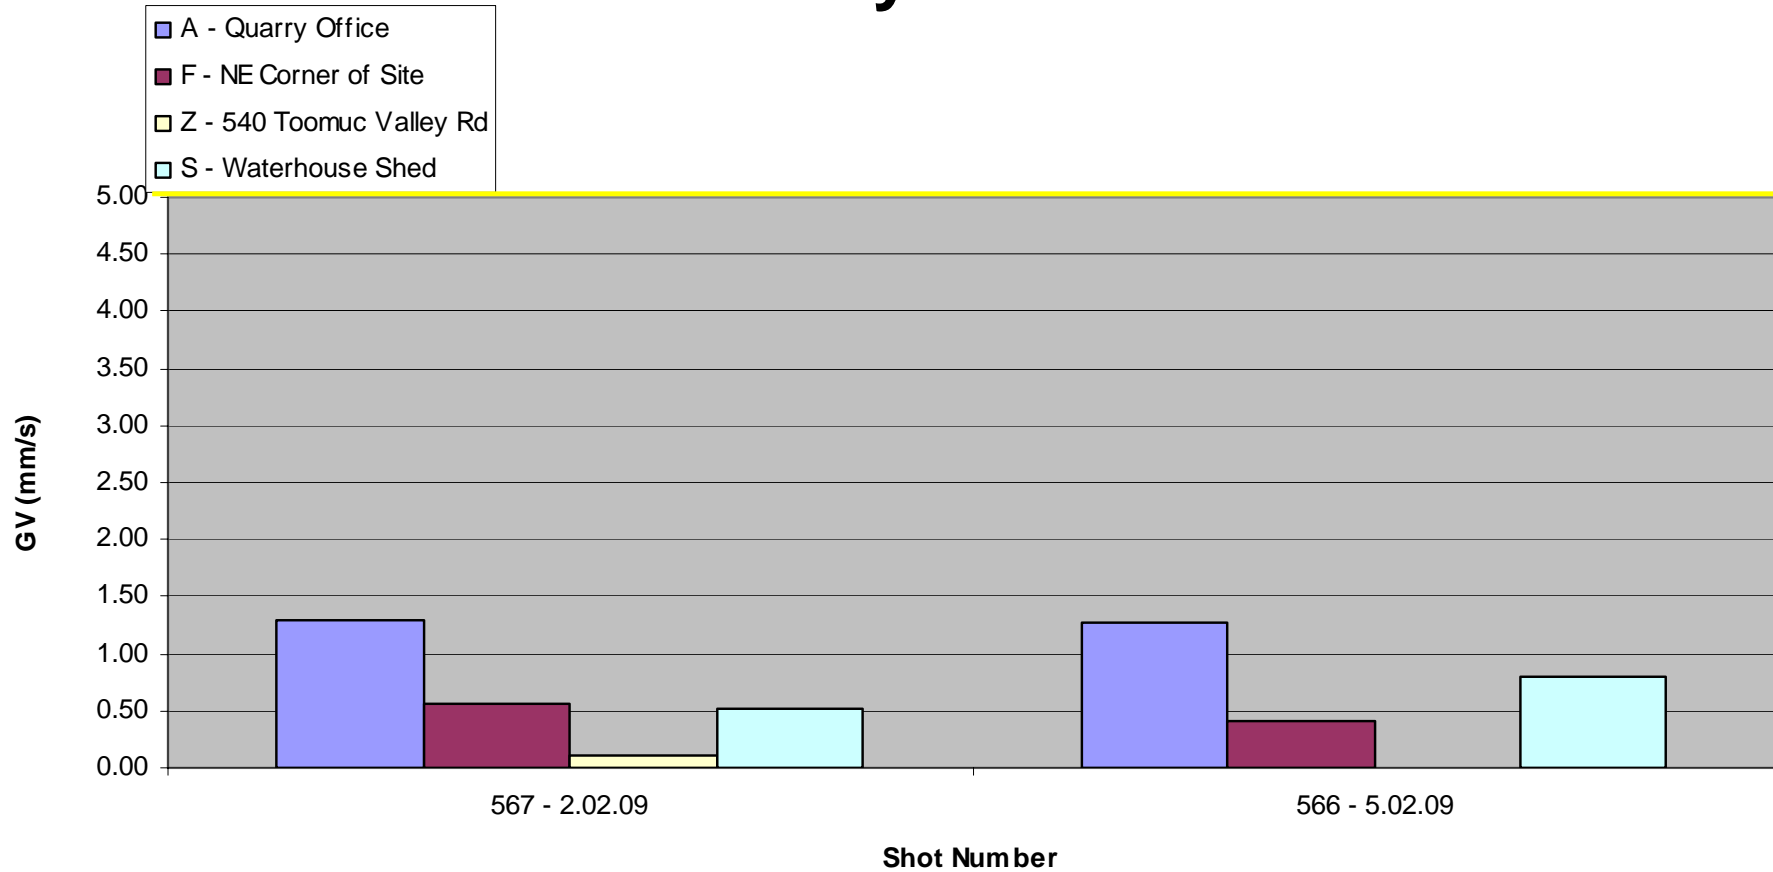
Figure 1.2: Ground Vibration by monitoring location and blast date. (Allowable Limit 5 mm/s)

Ground Vibration and Air Blast measurements conducted by specialist consultants were all within required standards as per *Mt Shamrock Quarry Environmental Management Plan Version 1: 18 January 2008*. Refer to Figures 1.2, 1.3.

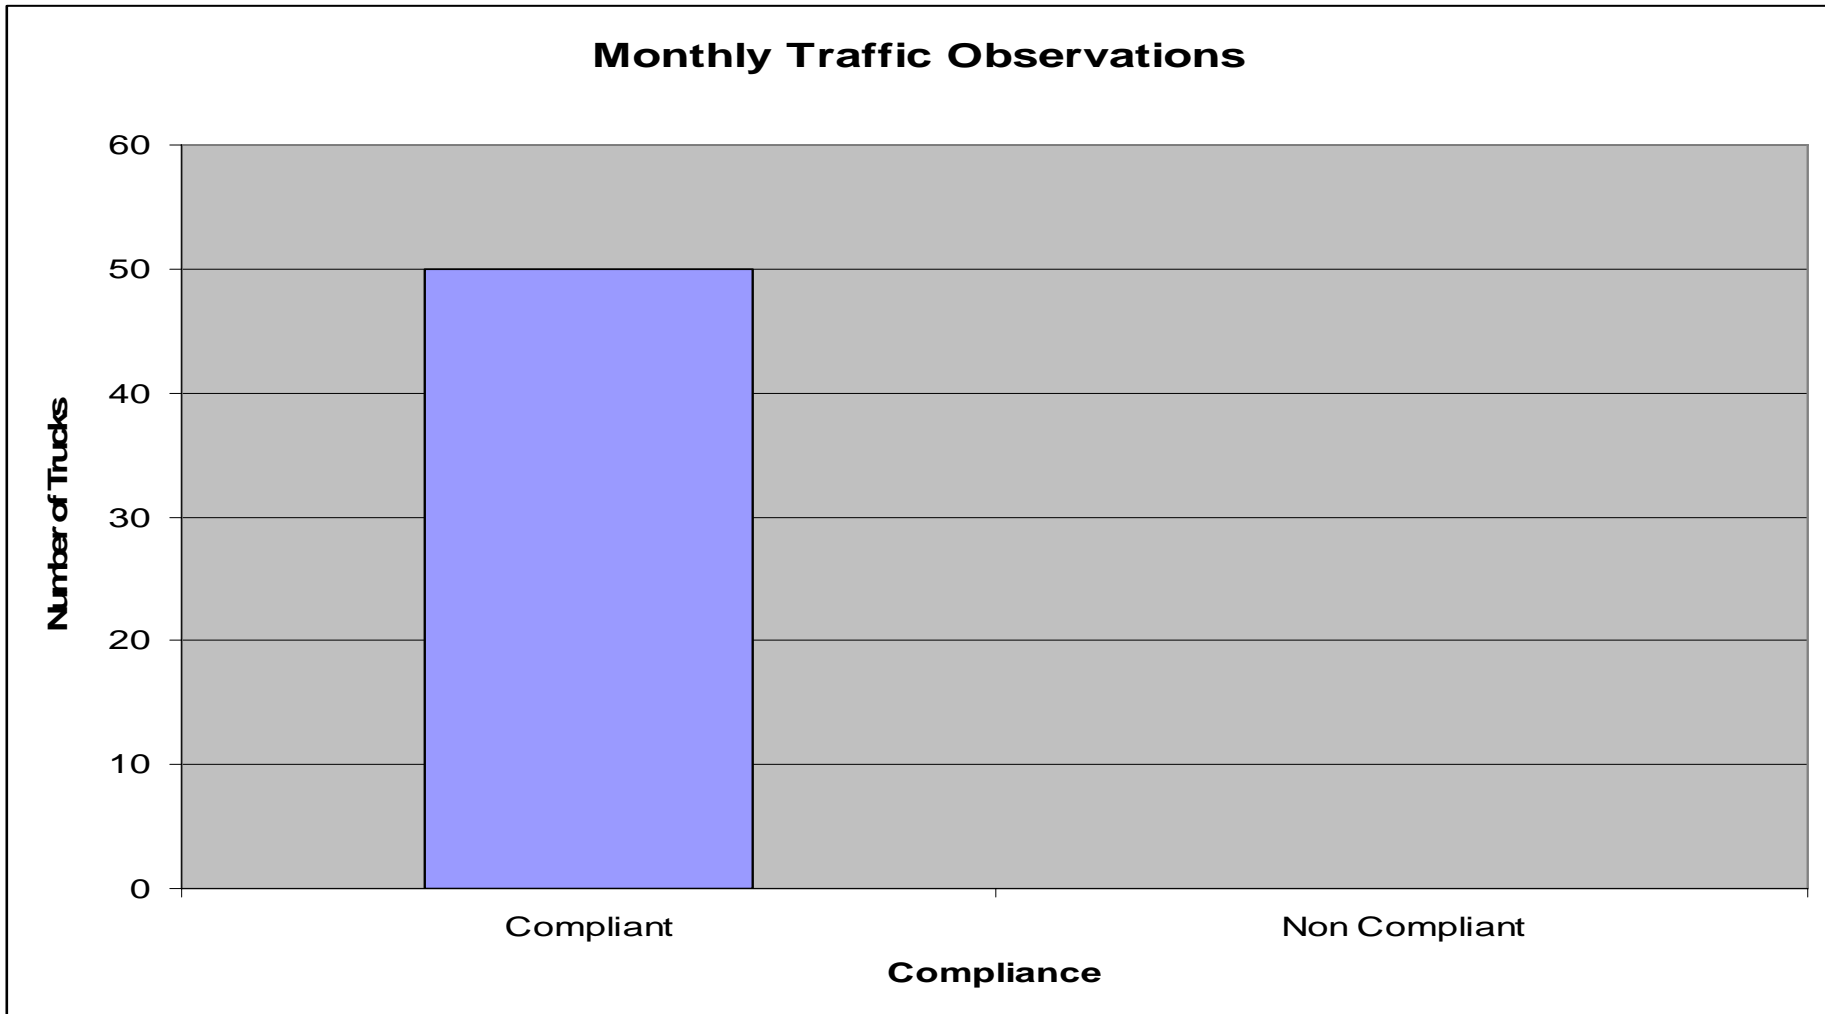
Figure 1.4: Traffic observations for reporting period

Evaluation of trucks leaving the site concluded that there is minimal material being tracked onto public roadways, all loads for the month were covered and correctly loaded. Trucks that were non-compliant were informed and advised that continued non-compliance may result in disciplinary action. Refer Figure 1.4
