Environmental Management Report Pakenham Quarry

For period 14th March 2009 – 14th April 2009

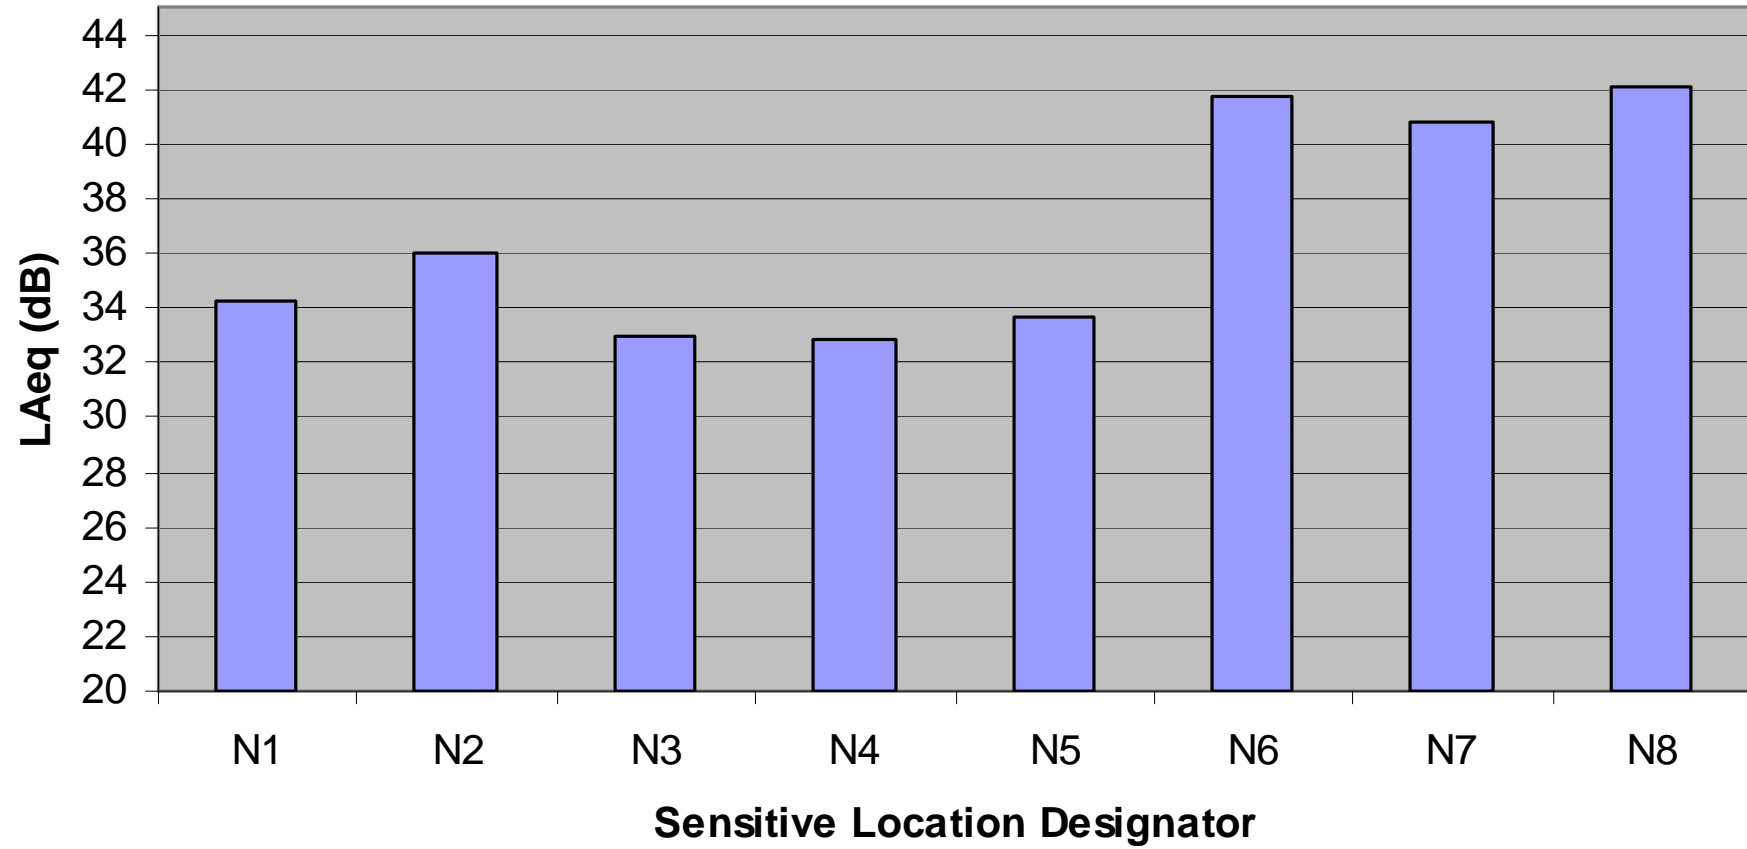
Figure1.1 Average Daily Values for Noise Monitoring of Sensitive Locations

All locations returned LAeq levels lower than the standards set out in *Mt Shamrock Quarry Environmental Management Plan Version 1: 18 January 2008*. At the date of this report there had been no complaints in relation to operating noise and therefore no noise level monitoring at a complainant's residence. Refer to Figure 1.1

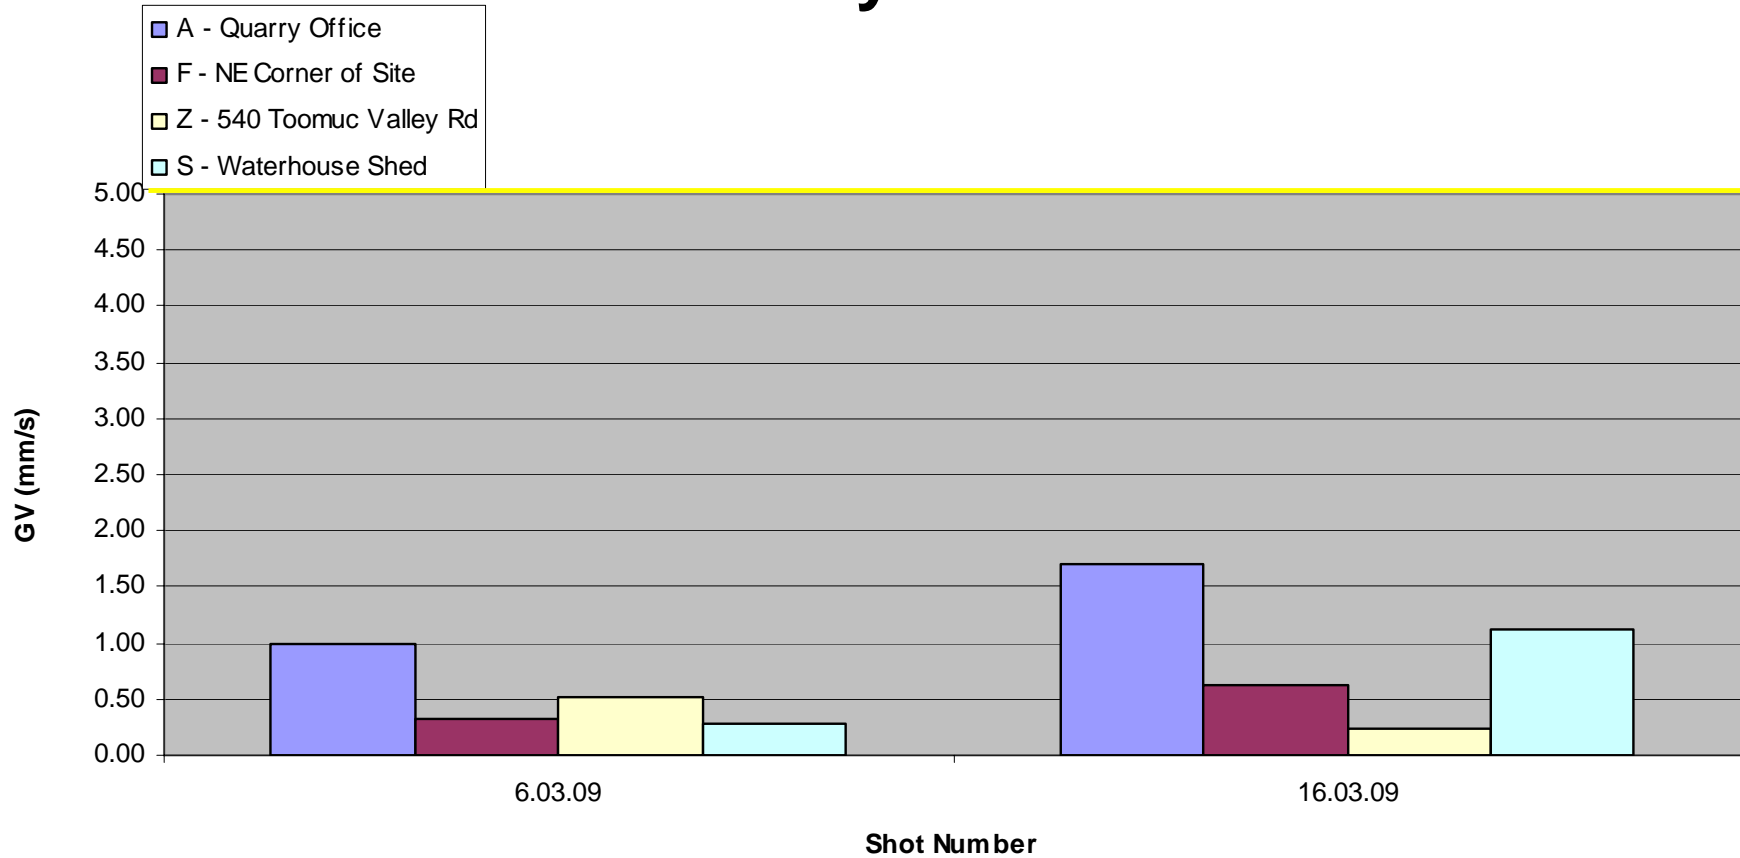
Figure 1.2: Ground Vibration by monitoring location and blast date. (Allowable Limit 5 mm/s)

Ground Vibration and Air Blast measurements conducted by specialist consultants were all within required standards as per *Mt Shamrock Quarry Environmental Management Plan Version 1: 18 January 2008*. Refer to Figures 1.2, 1.3.

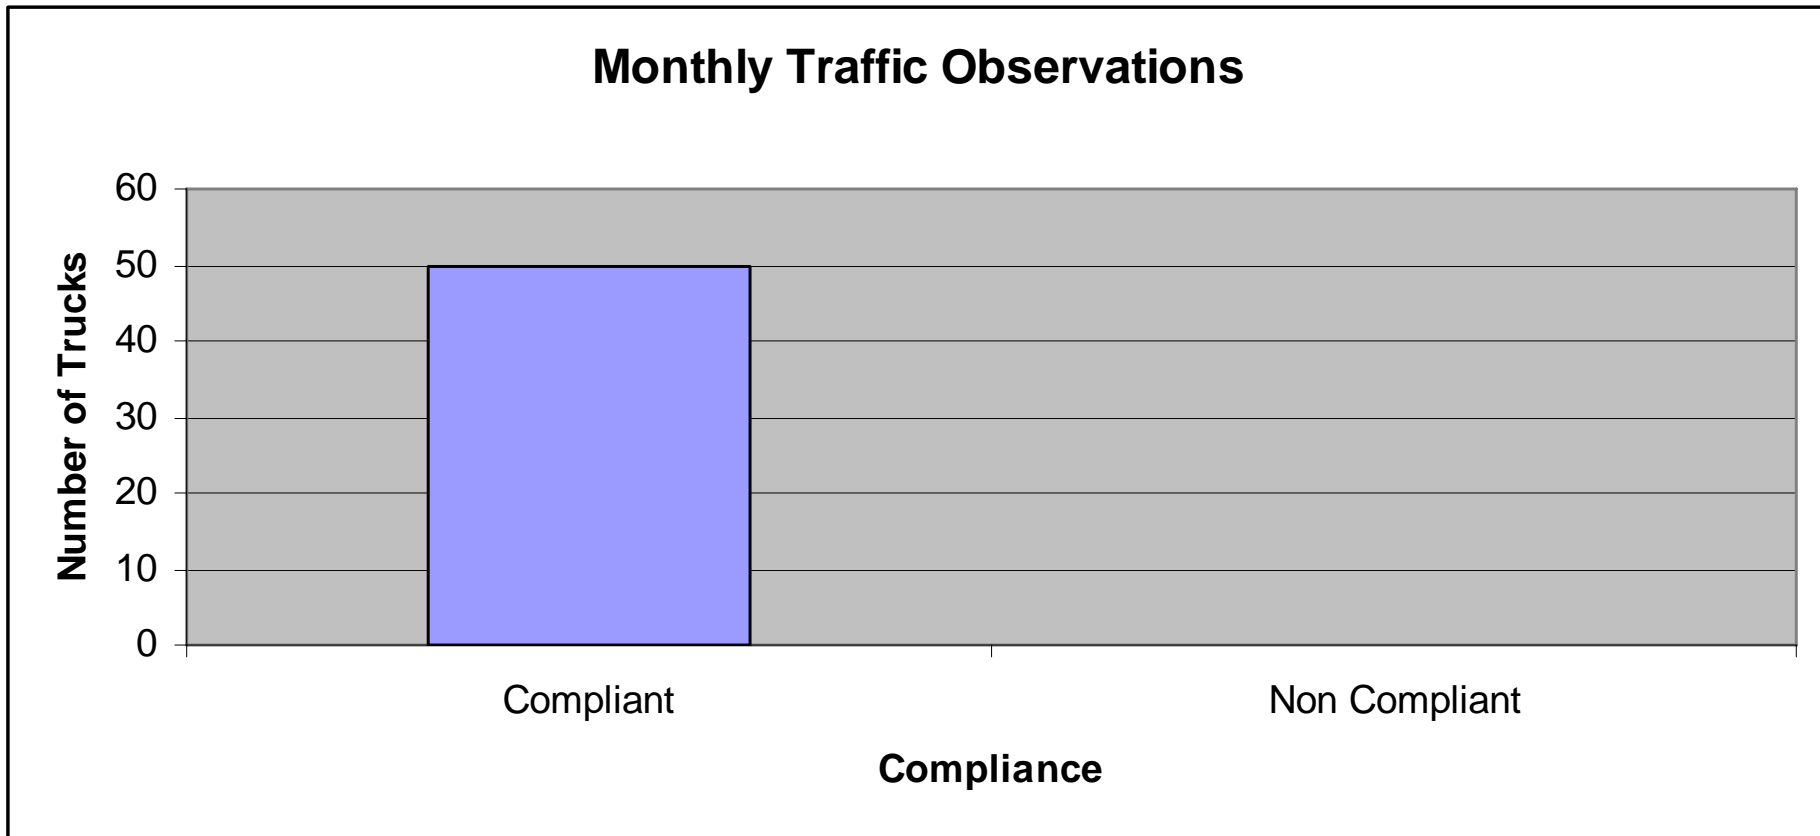
Figure 1.4: Traffic observations for reporting period

Evaluation of trucks leaving the site concluded that there is minimal material being tracked onto public roadways, all loads for the month were covered and correctly loaded.

Trucks that were non-compliant were informed and advised that continued non-compliance may result in disciplinary action. Refer Figure 1.4
