Environmental Management Report Pakenham Quarry

For period 14th March 2009 – 14th April 2009

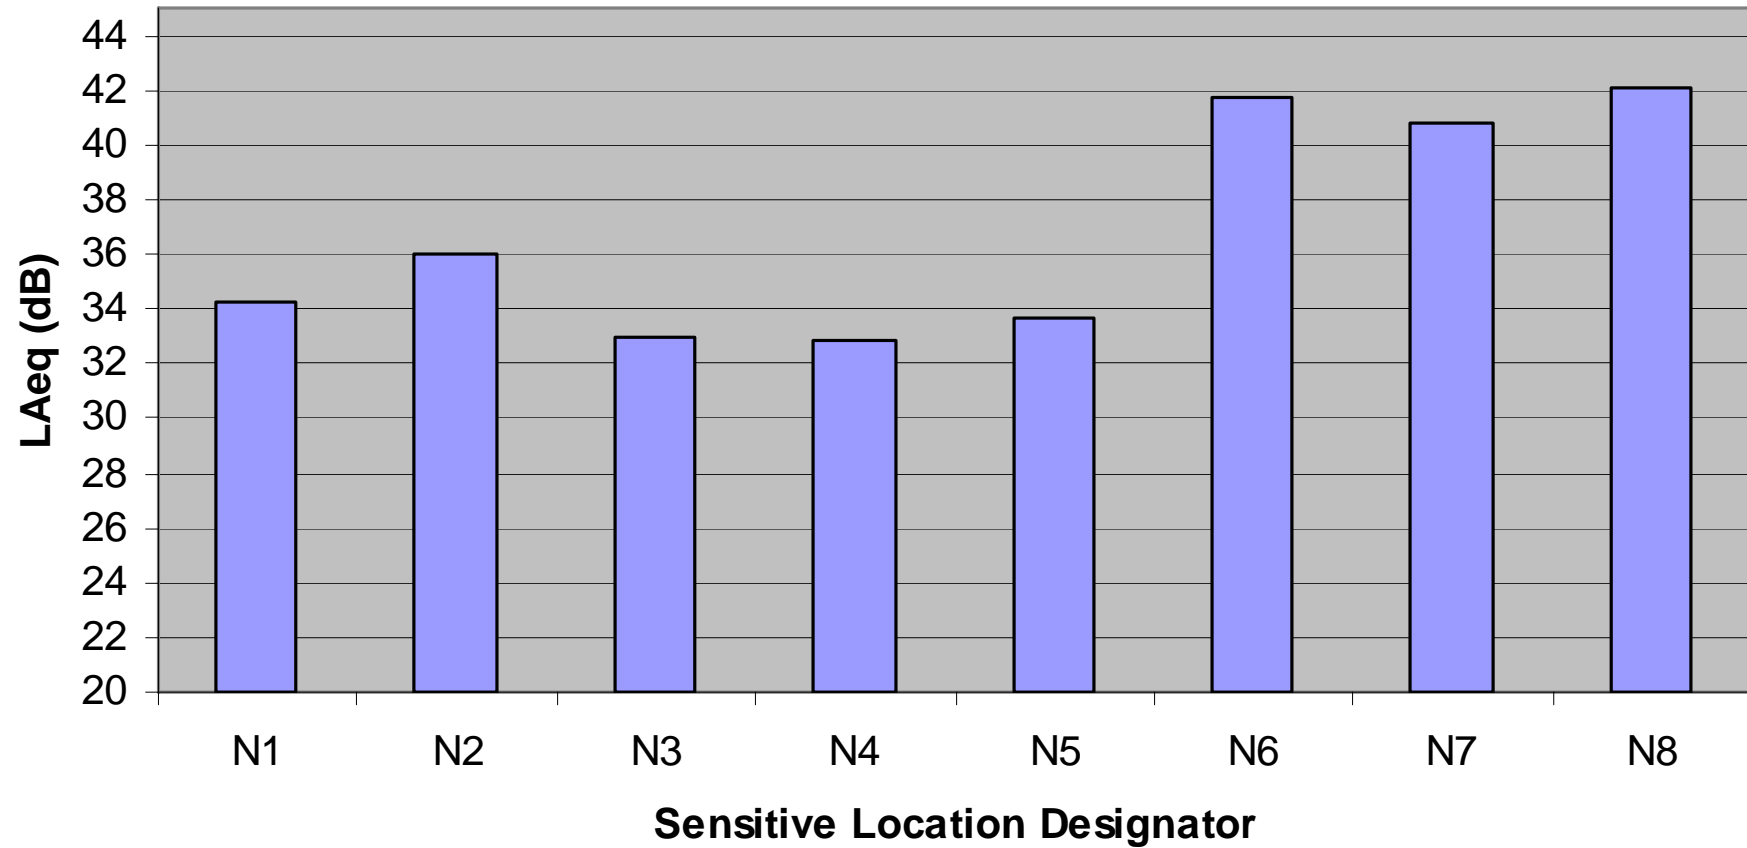
Figure1.1 Average Daily Values for Noise Monitoring of Sensitive Locations

All locations returned LAeq levels lower than the standards set out in *Mt Shamrock Quarry Environmental Management Plan Version 1: 18 January 2008*. At the date of this report there had been no complaints in relation to operating noise and therefore no noise level monitoring at a complainant's residence. Refer to Figure 1.1

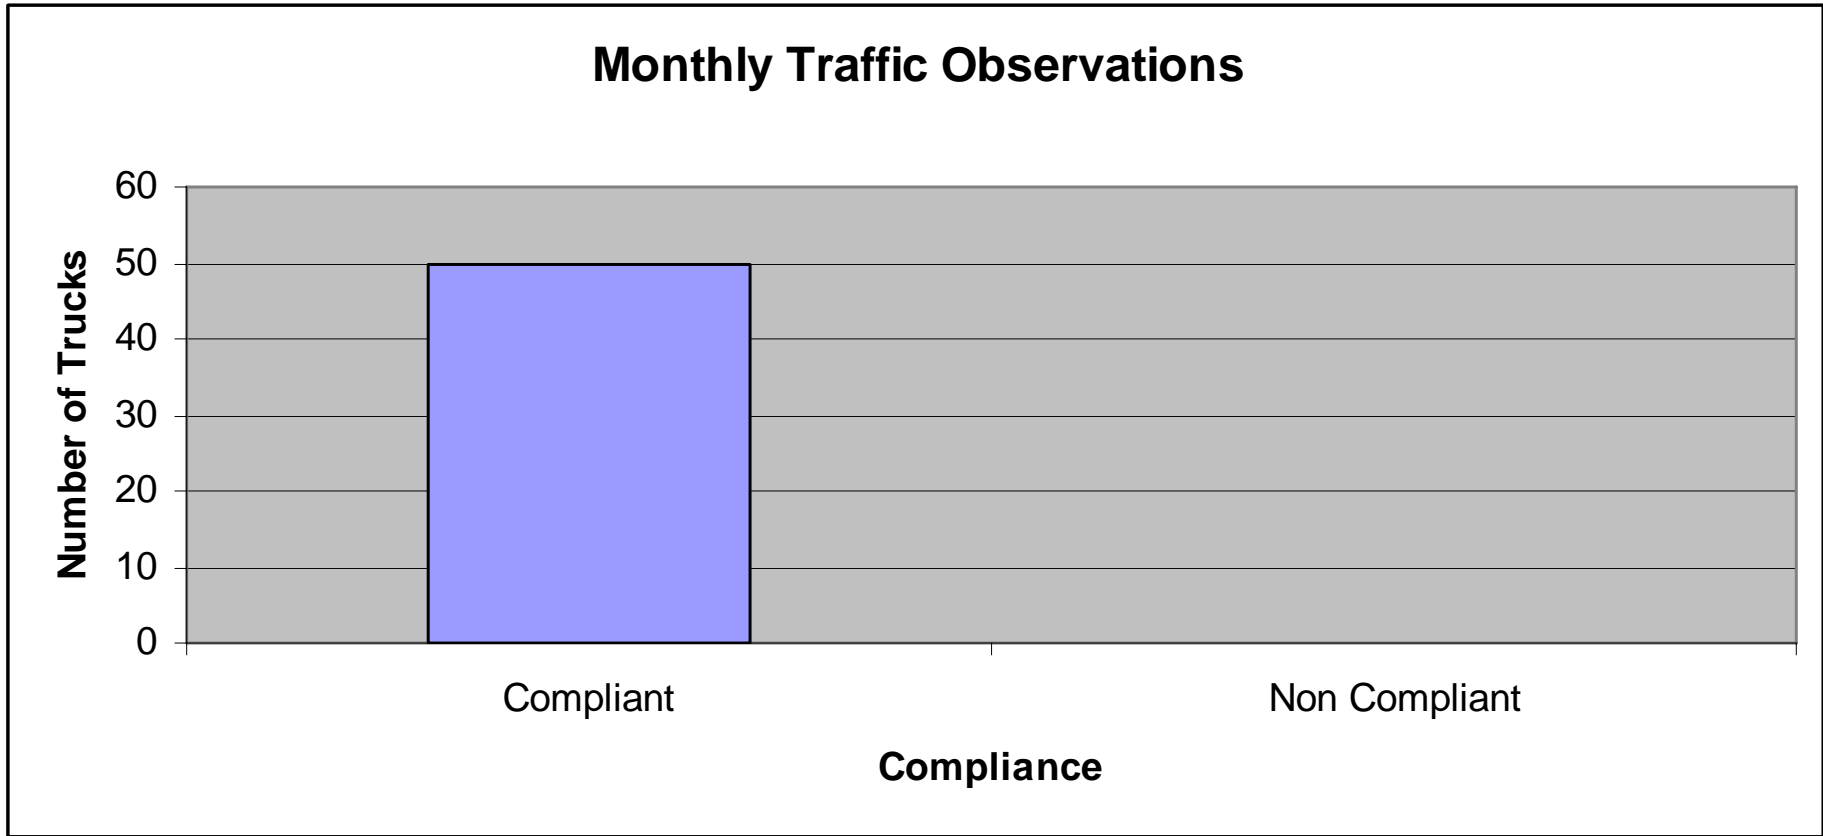
Figure 1.4: Traffic observations for reporting period

Evaluation of trucks leaving the site concluded that there is minimal material being tracked onto public roadways, all loads for the month were covered and correctly loaded.

Trucks that were non-compliant were informed and advised that continued non-compliance may result in disciplinary action. Refer Figure 1.4
