Environmental Management Report Pakenham Quarry

Compiled by
Damien Vardy

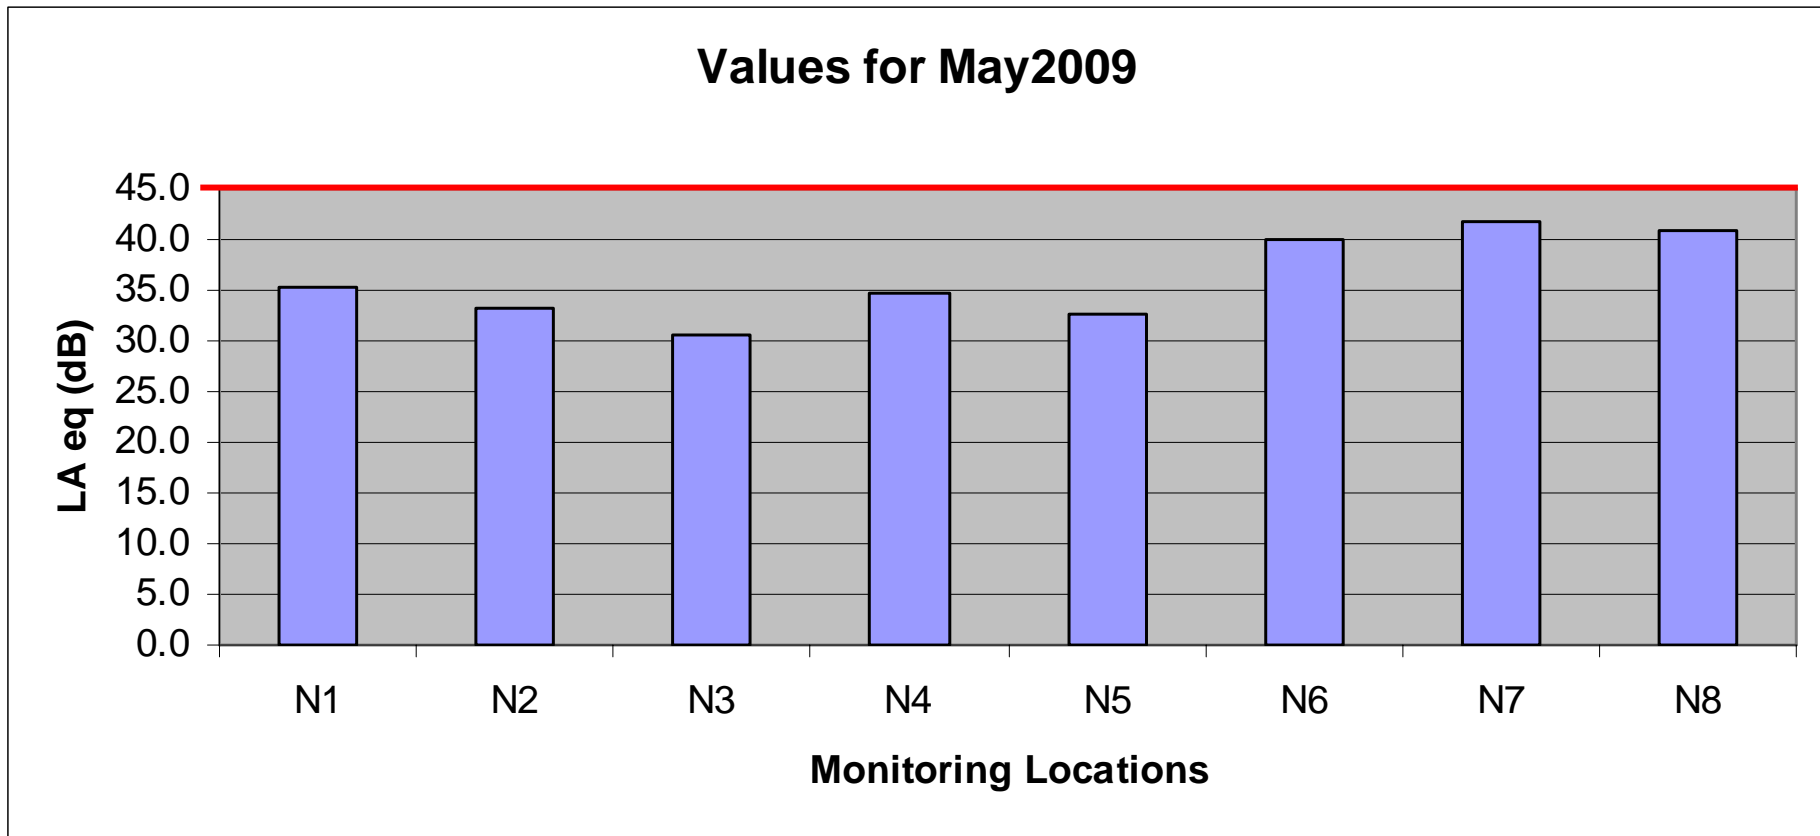
Figure1.1 Average Daily Values for Noise Monitoring of Sensitive Locations

All locations returned LAeq levels lower than the standards set out in *Mt Shamrock Quarry Environmental Management Plan Version 1: 18 January 2008*. At the date of this report there had been no complaints in relation to operating noise and therefore no noise level monitoring at a complainant's residence. Refer to Figure 1.1

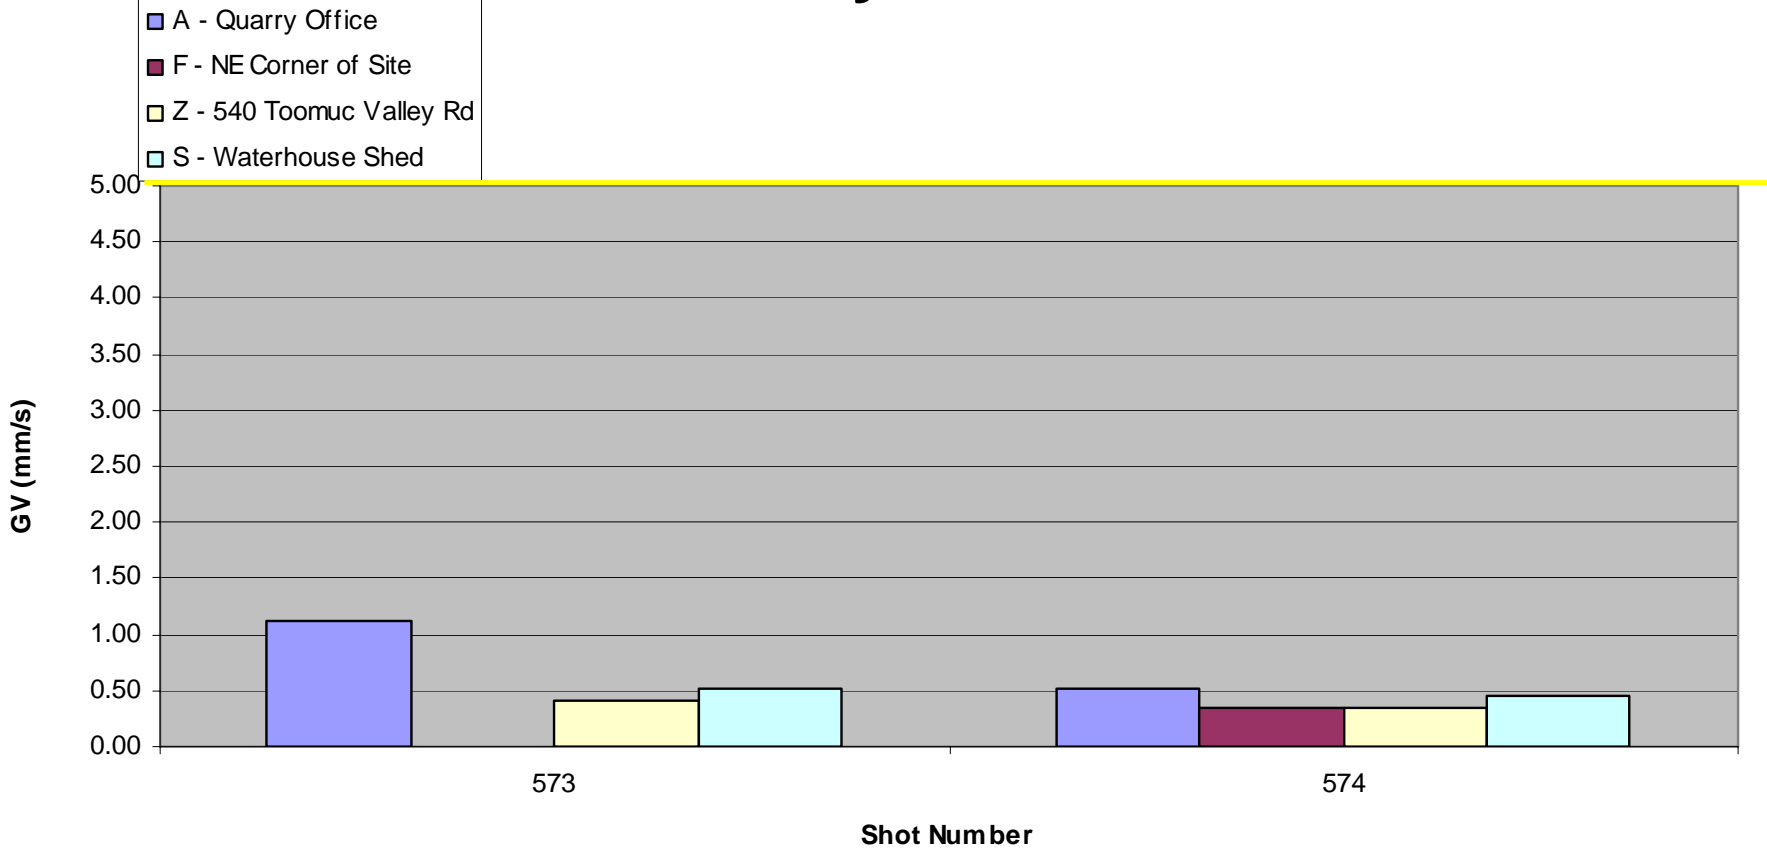
Figure 1.2: Ground Vibration by monitoring location and blast date. (Allowable Limit 5 mm/s)

Ground Vibration and Air Blast measurements conducted by specialist consultants were all within required standards as per *Mt Shamrock Quarry Environmental Management Plan Version 1: 18 January 2008*. Refer to Figures 1.2, 1.3.

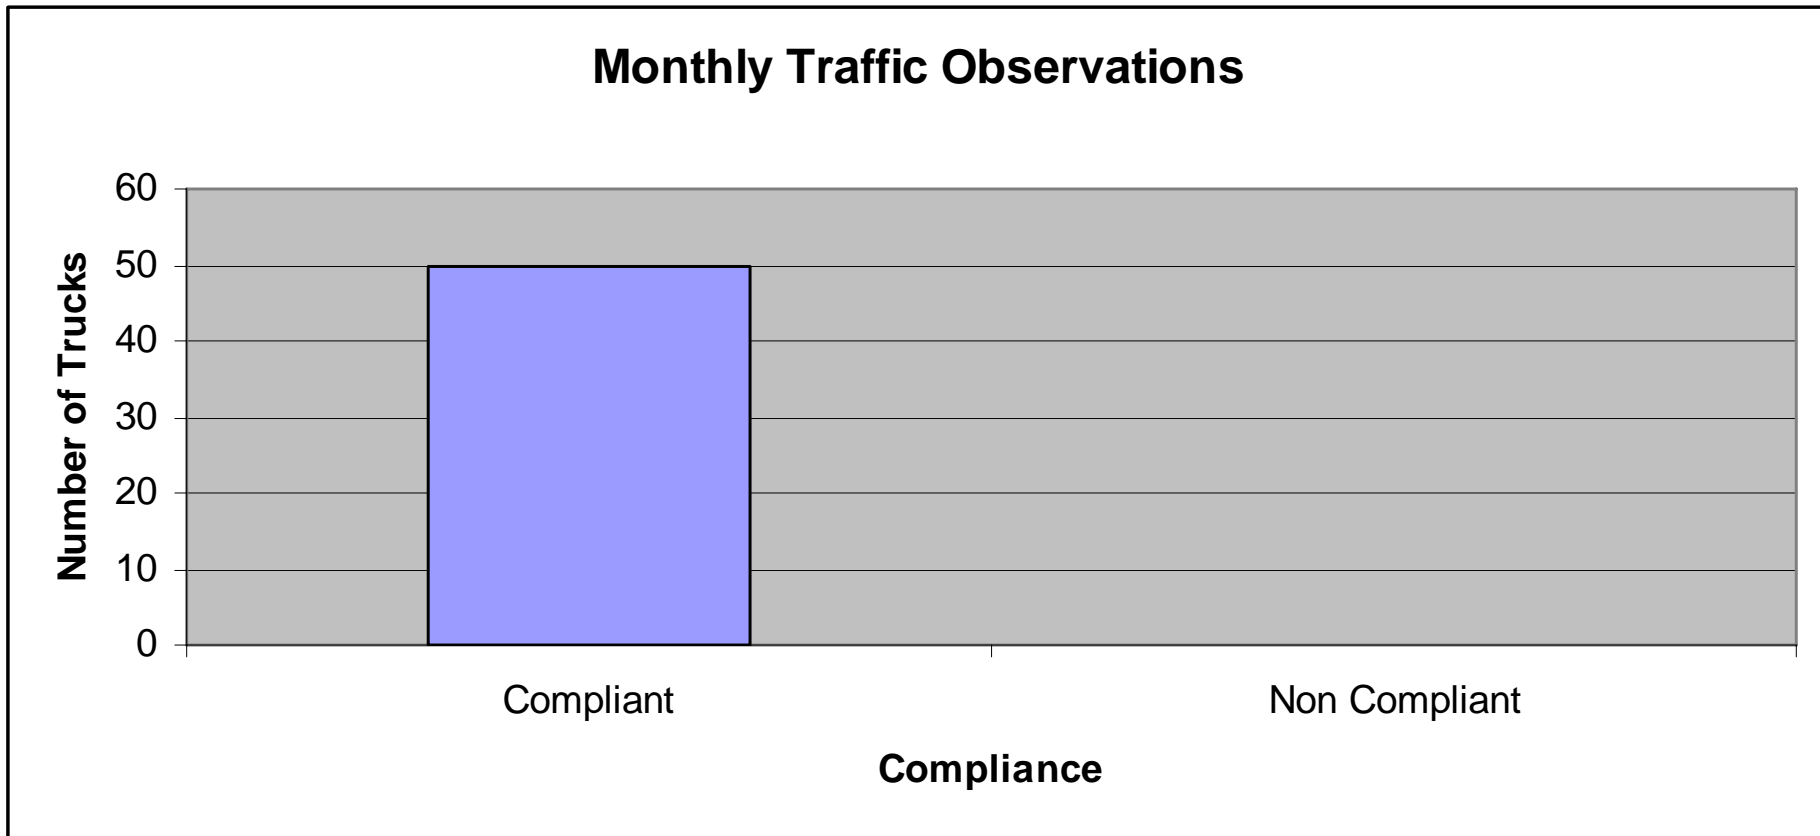
Figure 1.4: Traffic observations for reporting period

Evaluation of trucks leaving the site concluded that there is minimal material being tracked onto public roadways, all loads for the month were covered and correctly loaded. Trucks that were non-compliant were informed and advised that continued non-compliance may result in disciplinary action. Refer Figure 1.4
