Environmental Management Report Pakenham Quarry

Compiled by
Damien Vardy

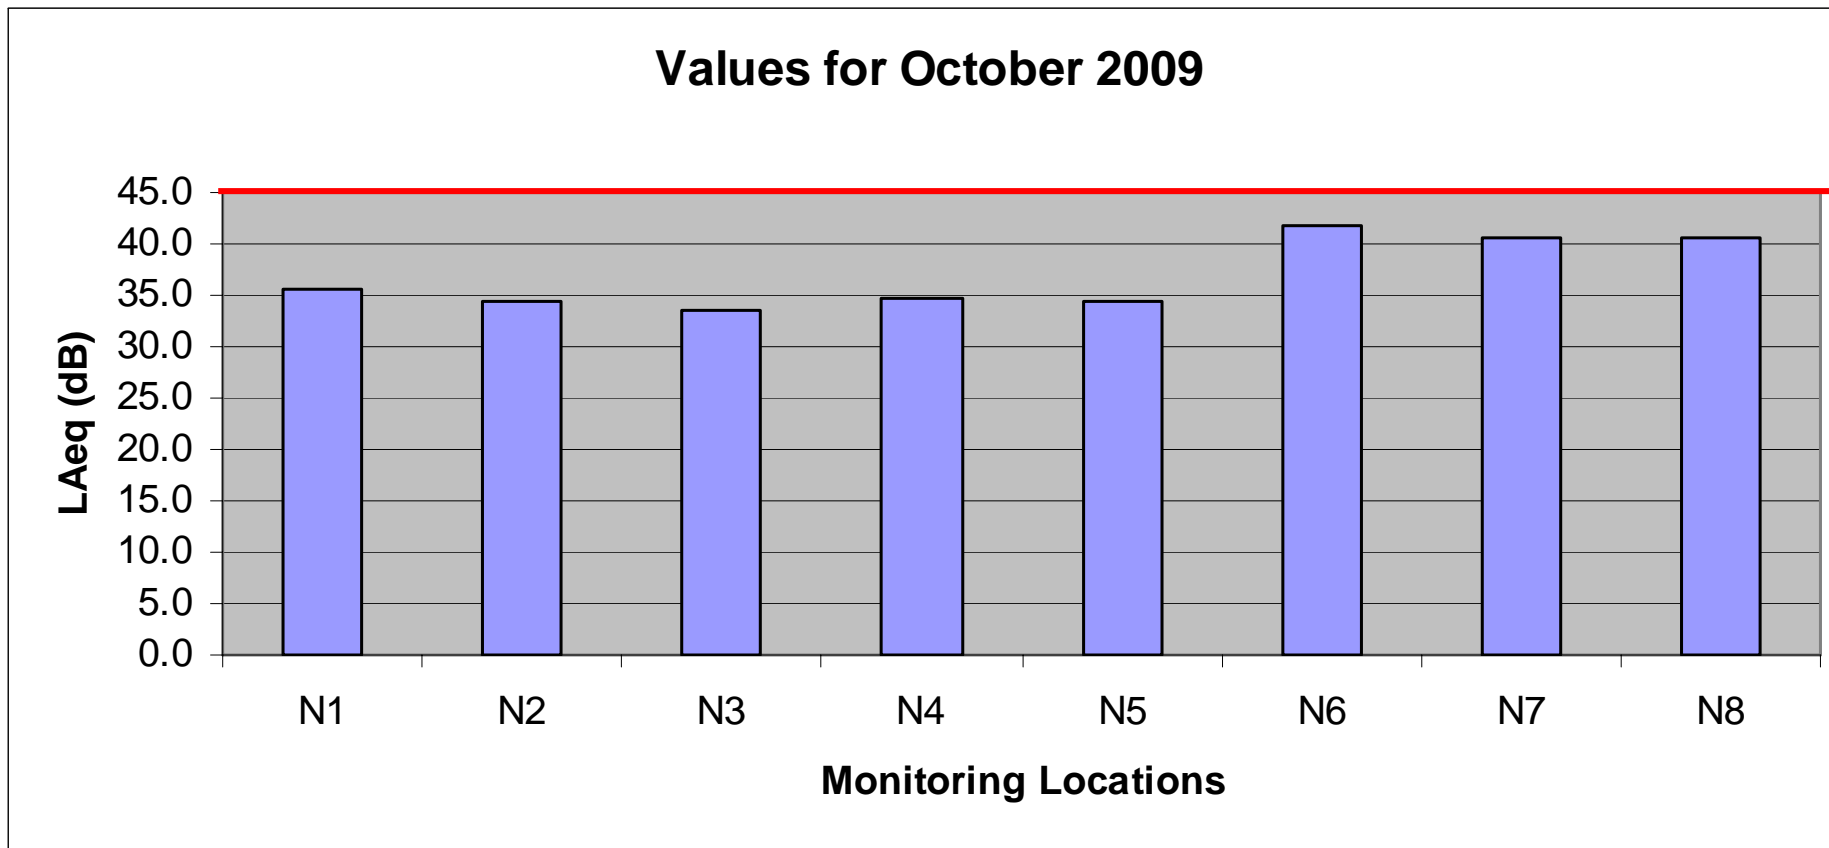
Figure1.1 Average Daily Values for Noise Monitoring of Sensitive Locations

All locations returned LAeq levels lower than the standards set out in *Mt Shamrock Quarry Environmental Management Plan Version 1: 18 January 2008*. At the date of this report there had been no complaints in relation to operating noise and therefore no noise level monitoring at a complainant's residence. Refer to Figure 1.1

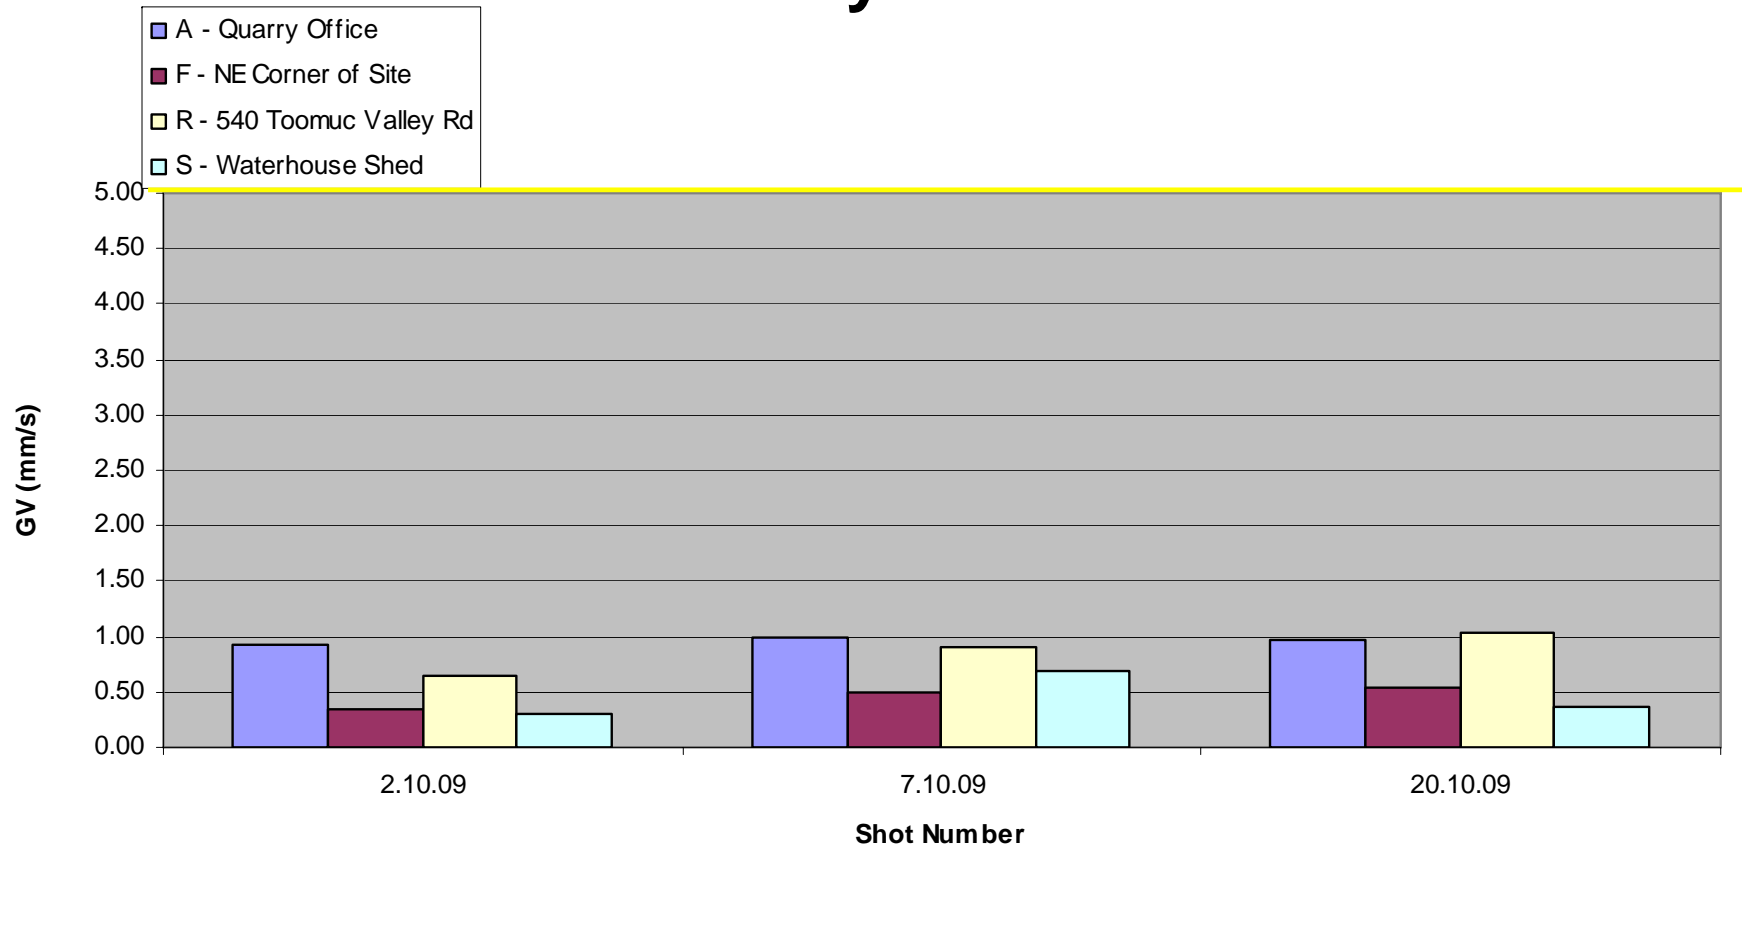
Figure 1.2: Ground Vibration by monitoring location and blast date. (Allowable Limit 5 mm/s).

Ground Vibration and Air Blast measurements conducted by specialist consultants were all within required standards as per *Mt Shamrock Quarry Environmental Management Plan Version 1: 18 January 2008*. Refer to Figures 1.2, 1.3.

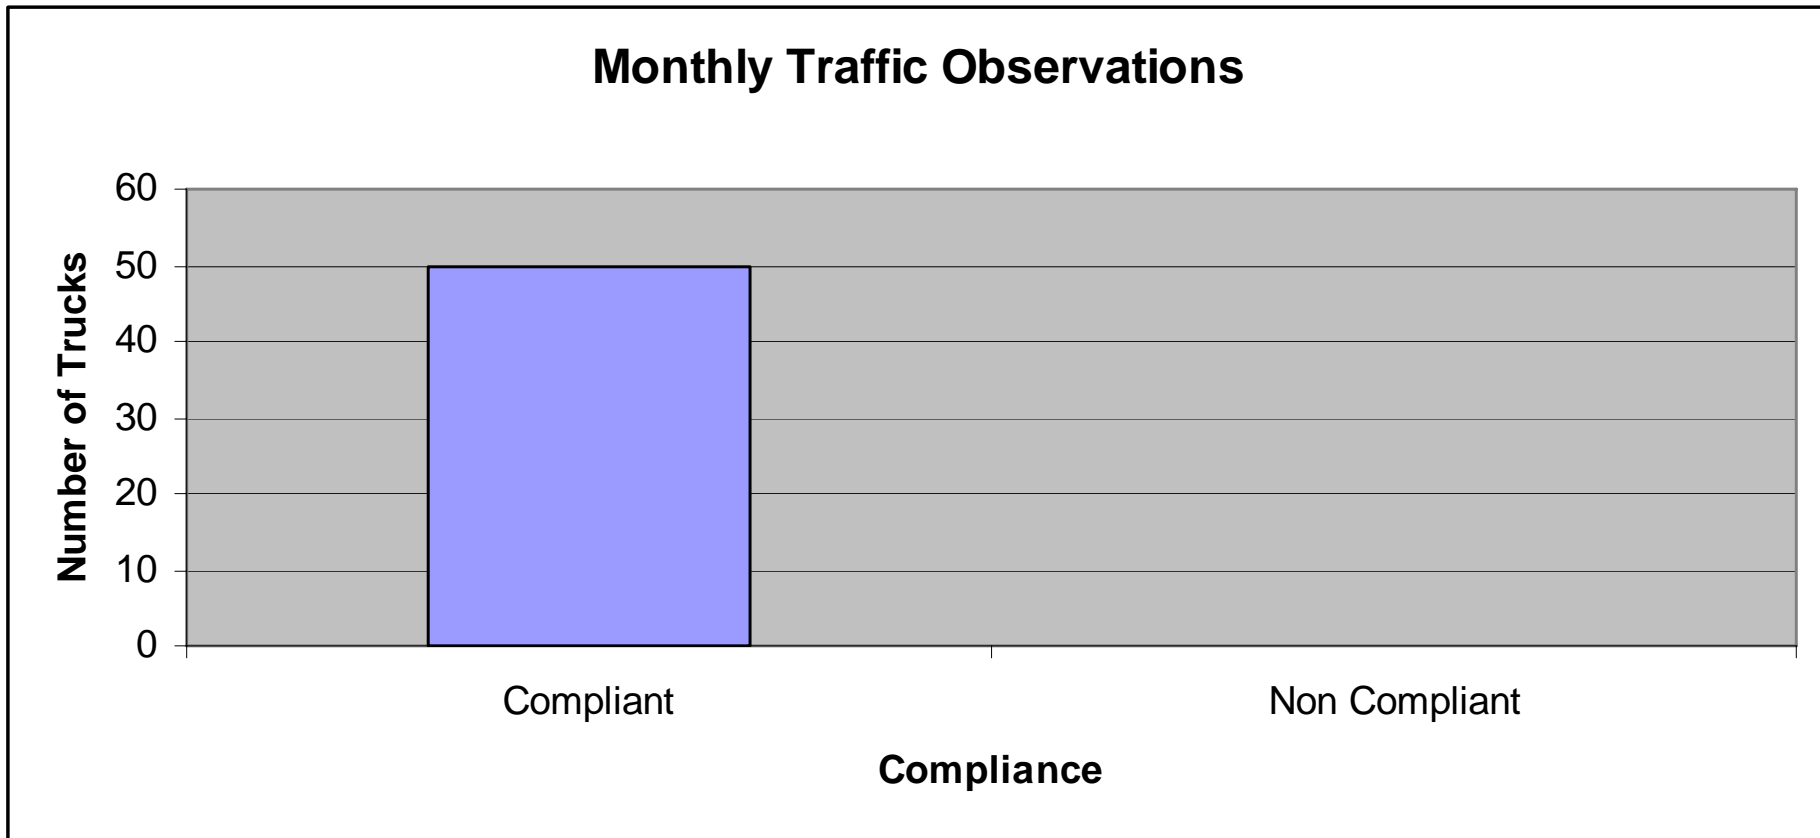
Figure 1.4: Traffic observations for reporting period

Evaluation of trucks leaving the site concluded that there is minimal material being tracked onto public roadways, all loads for the month were covered and correctly loaded. Trucks that were non-compliant were informed and advised that continued non-compliance may result in disciplinary action. Refer Figure 1.4
