Environmental Management Report Pakenham Quarry

Abstract

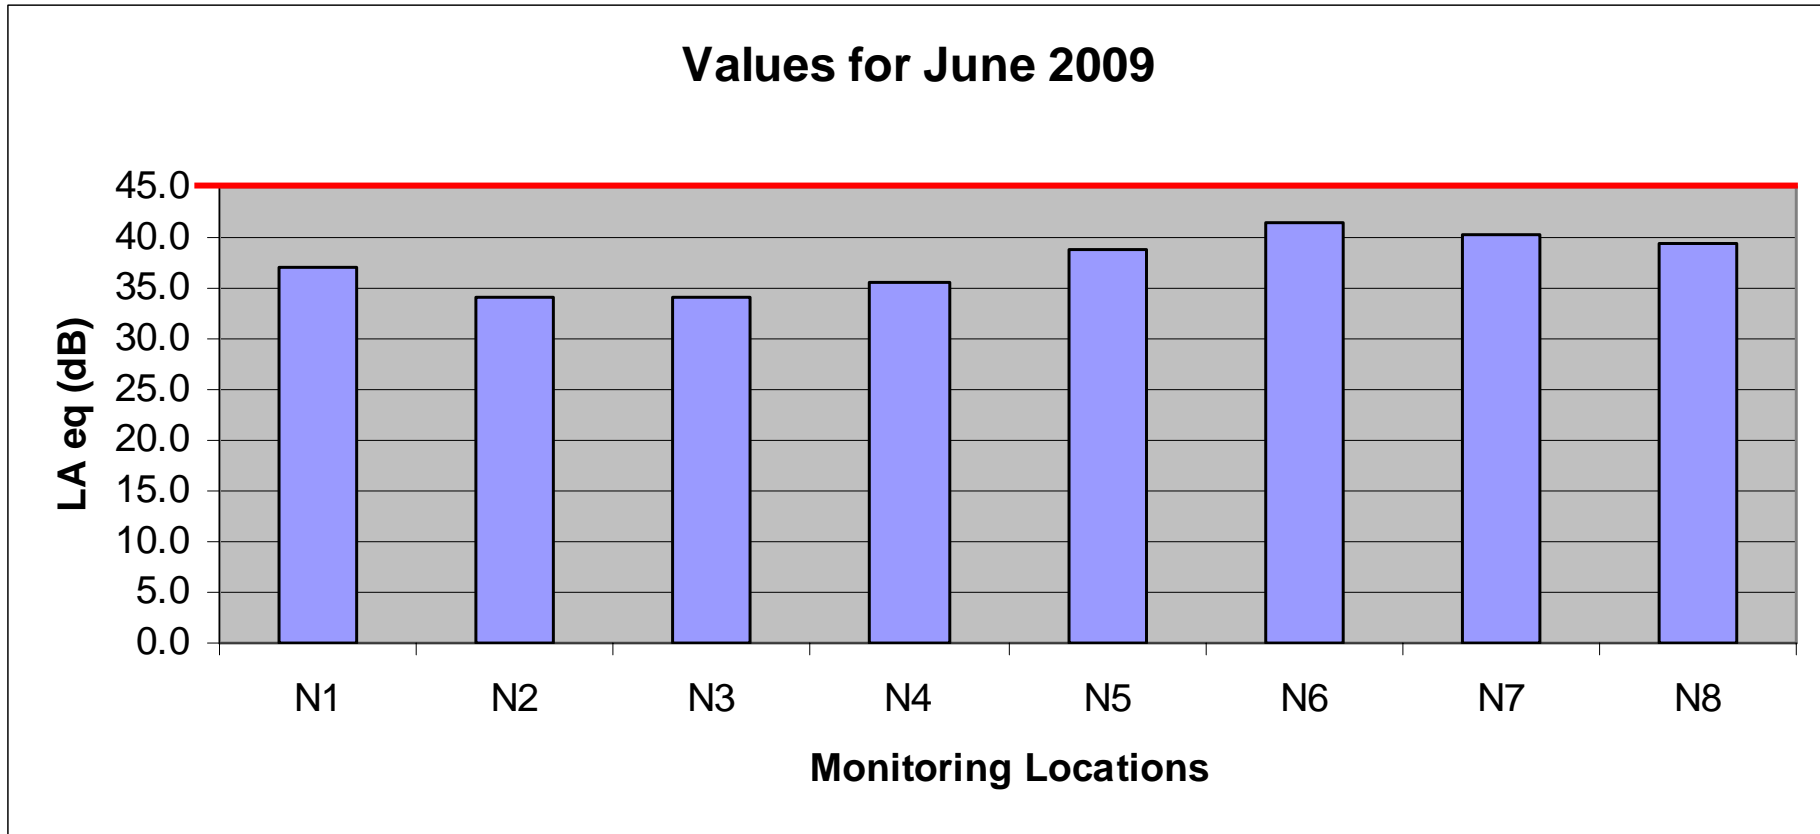
All locations returned LAeq levels lower than the standards set out in *Mt Shamrock Quarry Environmental Management Plan Version 1: 18 January 2008*. At the date of this report there had been no complaints in relation to operating noise and therefore no noise level monitoring at a complainant's residence. Refer to Figure 1.1

Figure1.1 Average Daily Values for Noise Monitoring of Sensitive Locations

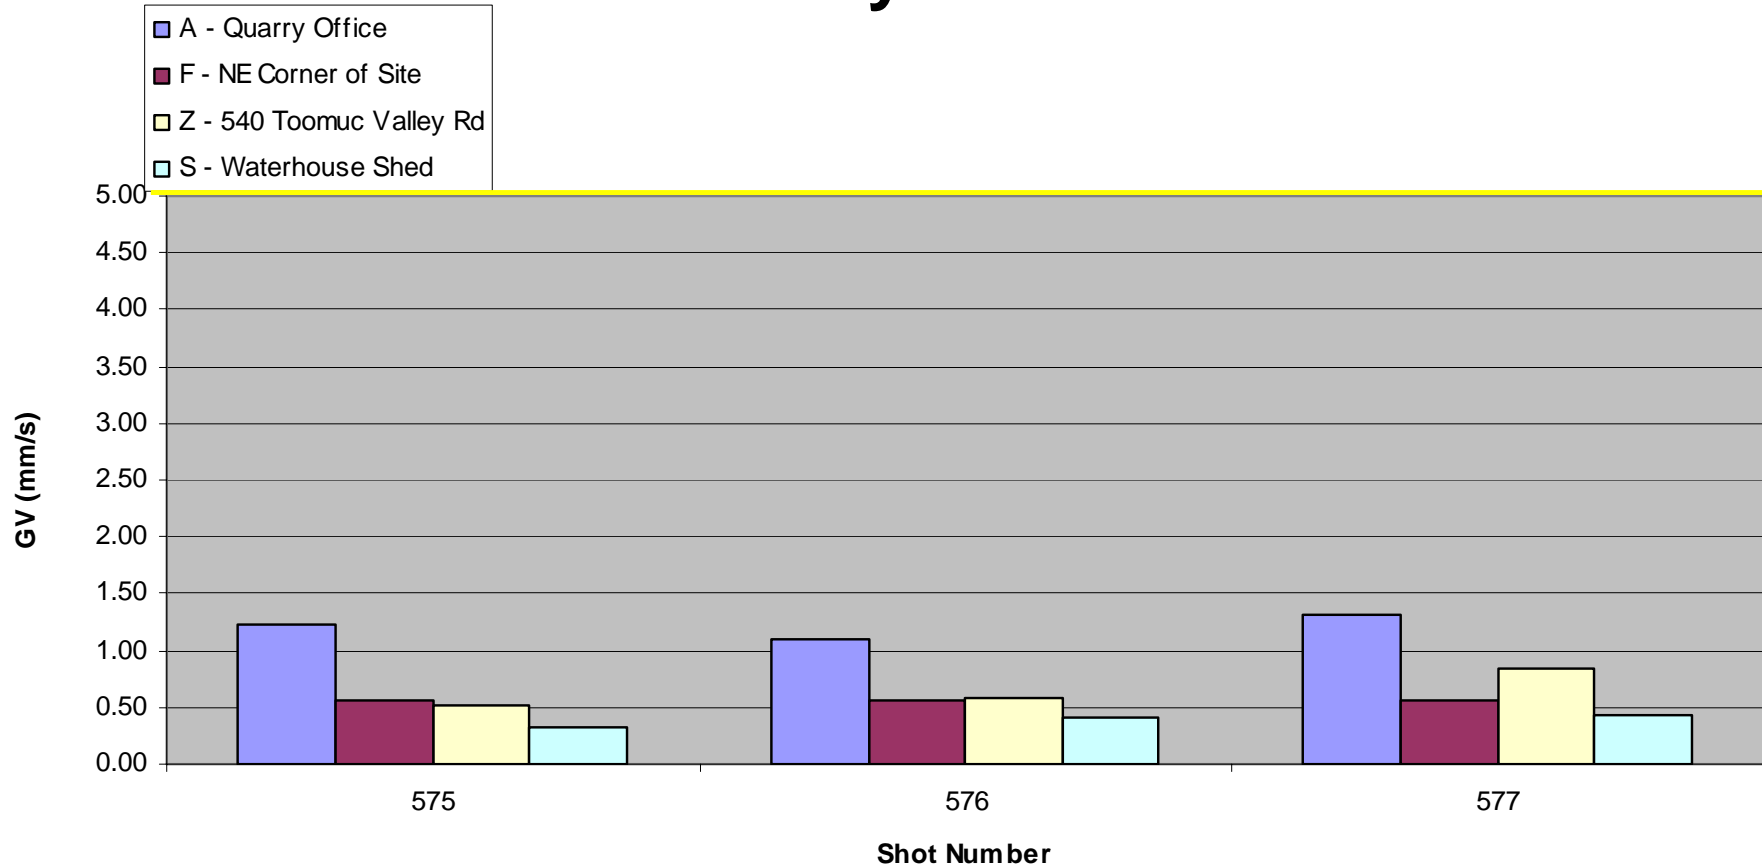
Ground Vibration and Air Blast measurements conducted by specialist consultants were all within required standards as per *Mt Shamrock Quarry Environmental Management Plan Version 1: 18 January 2008*. Refer to Figures 1.2, 1.3.

Figure 1.2: Ground Vibration by monitoring location and blast date. (Allowable Limit 5 mm/s)

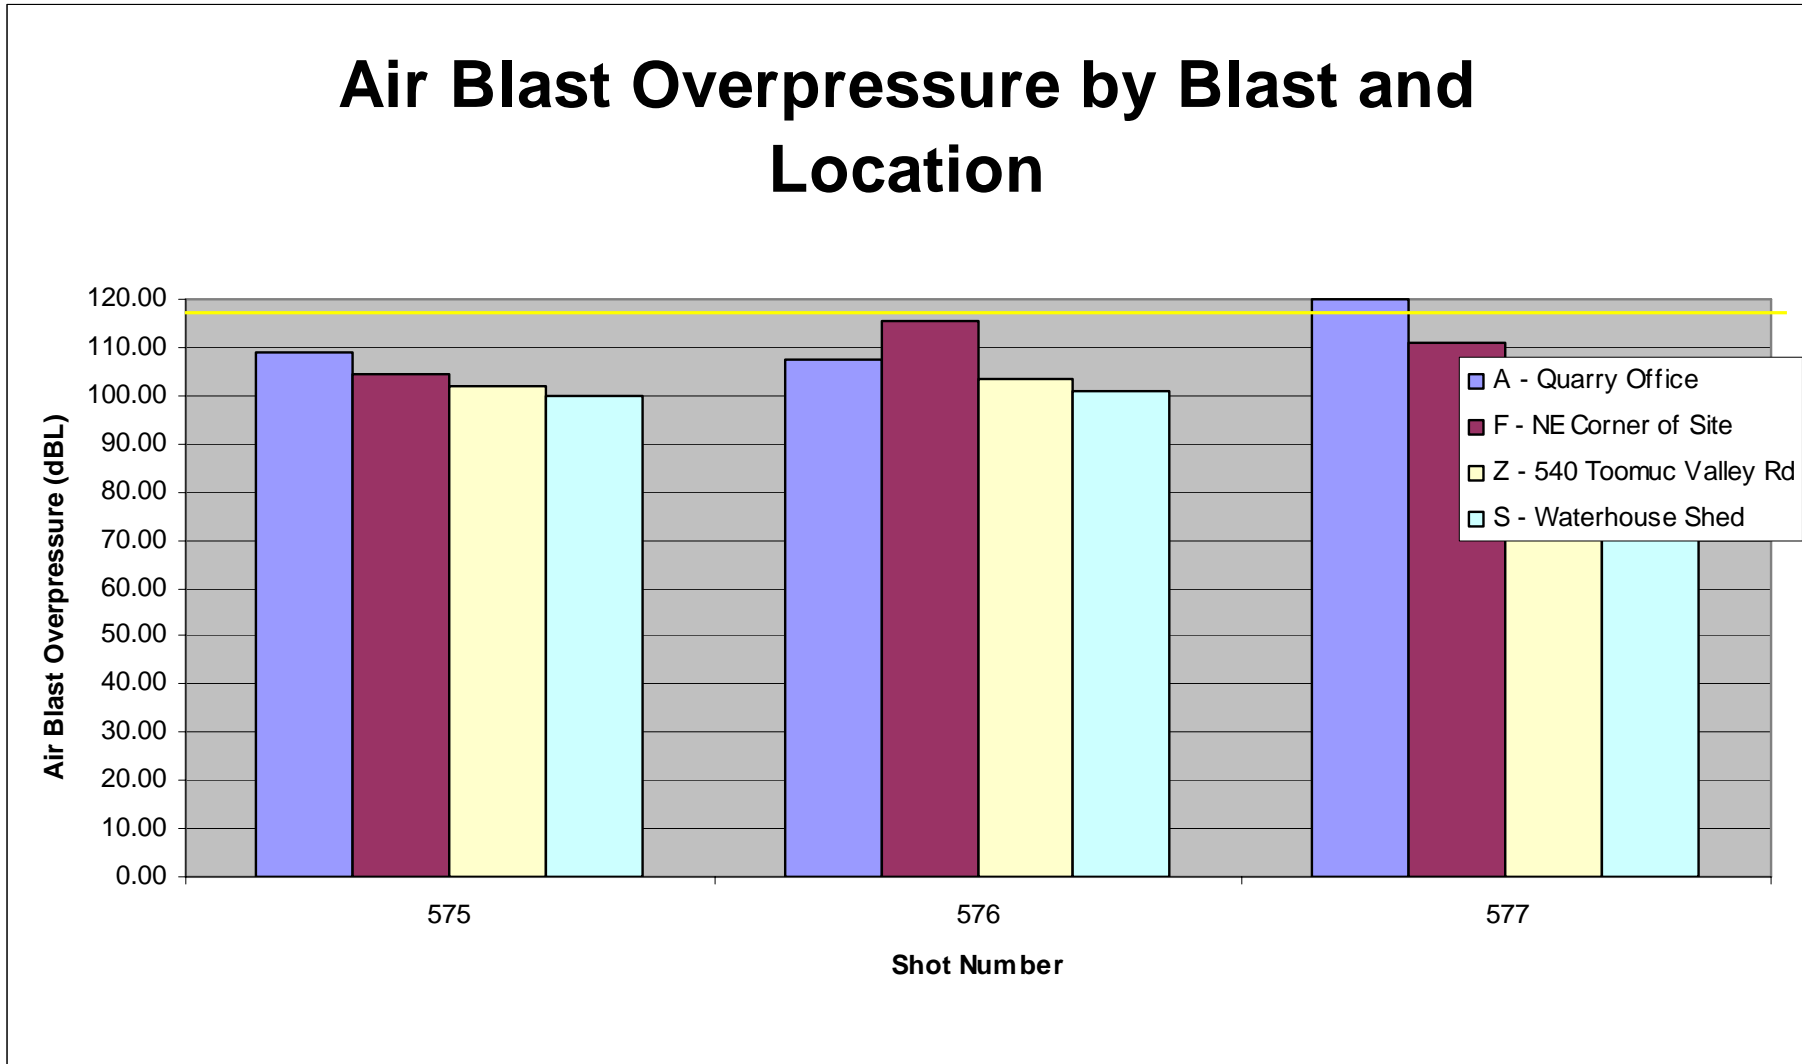
Figure 1.3: Air Blast by Monitoring Location and Blast Date (Allowable Limit 115 dBL in 95% of blasts, 120 dBL in 5% of blasts in 12month period).

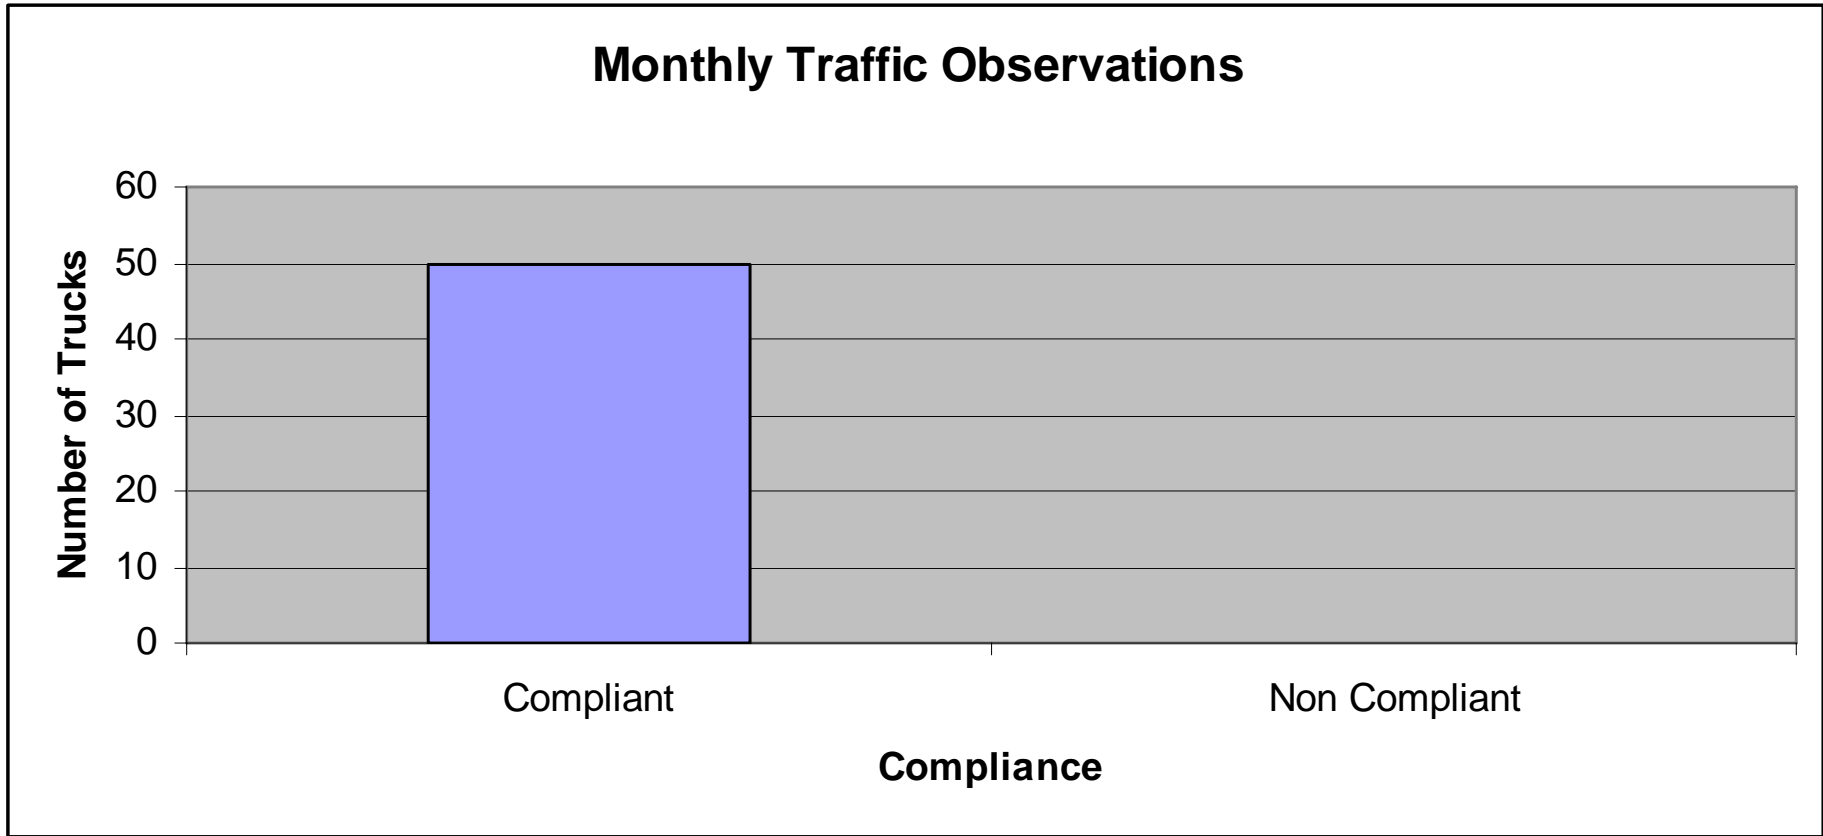
Evaluation of trucks leaving the site concluded that there is minimal material being tracked onto public roadways, all loads for the month were covered and correctly loaded. Trucks that were non-compliant were informed and advised that continued non-compliance may result in disciplinary action. Refer Figure 1.4. Upgrade works have been completed on the wheel wash and the effectiveness of this wheel-wash has been greatly improved.

Figure 1.4: Traffic observations for reporting period
