Environmental Management Report Pakenham Quarry

For period 14th December 2008 – 14th January 2008

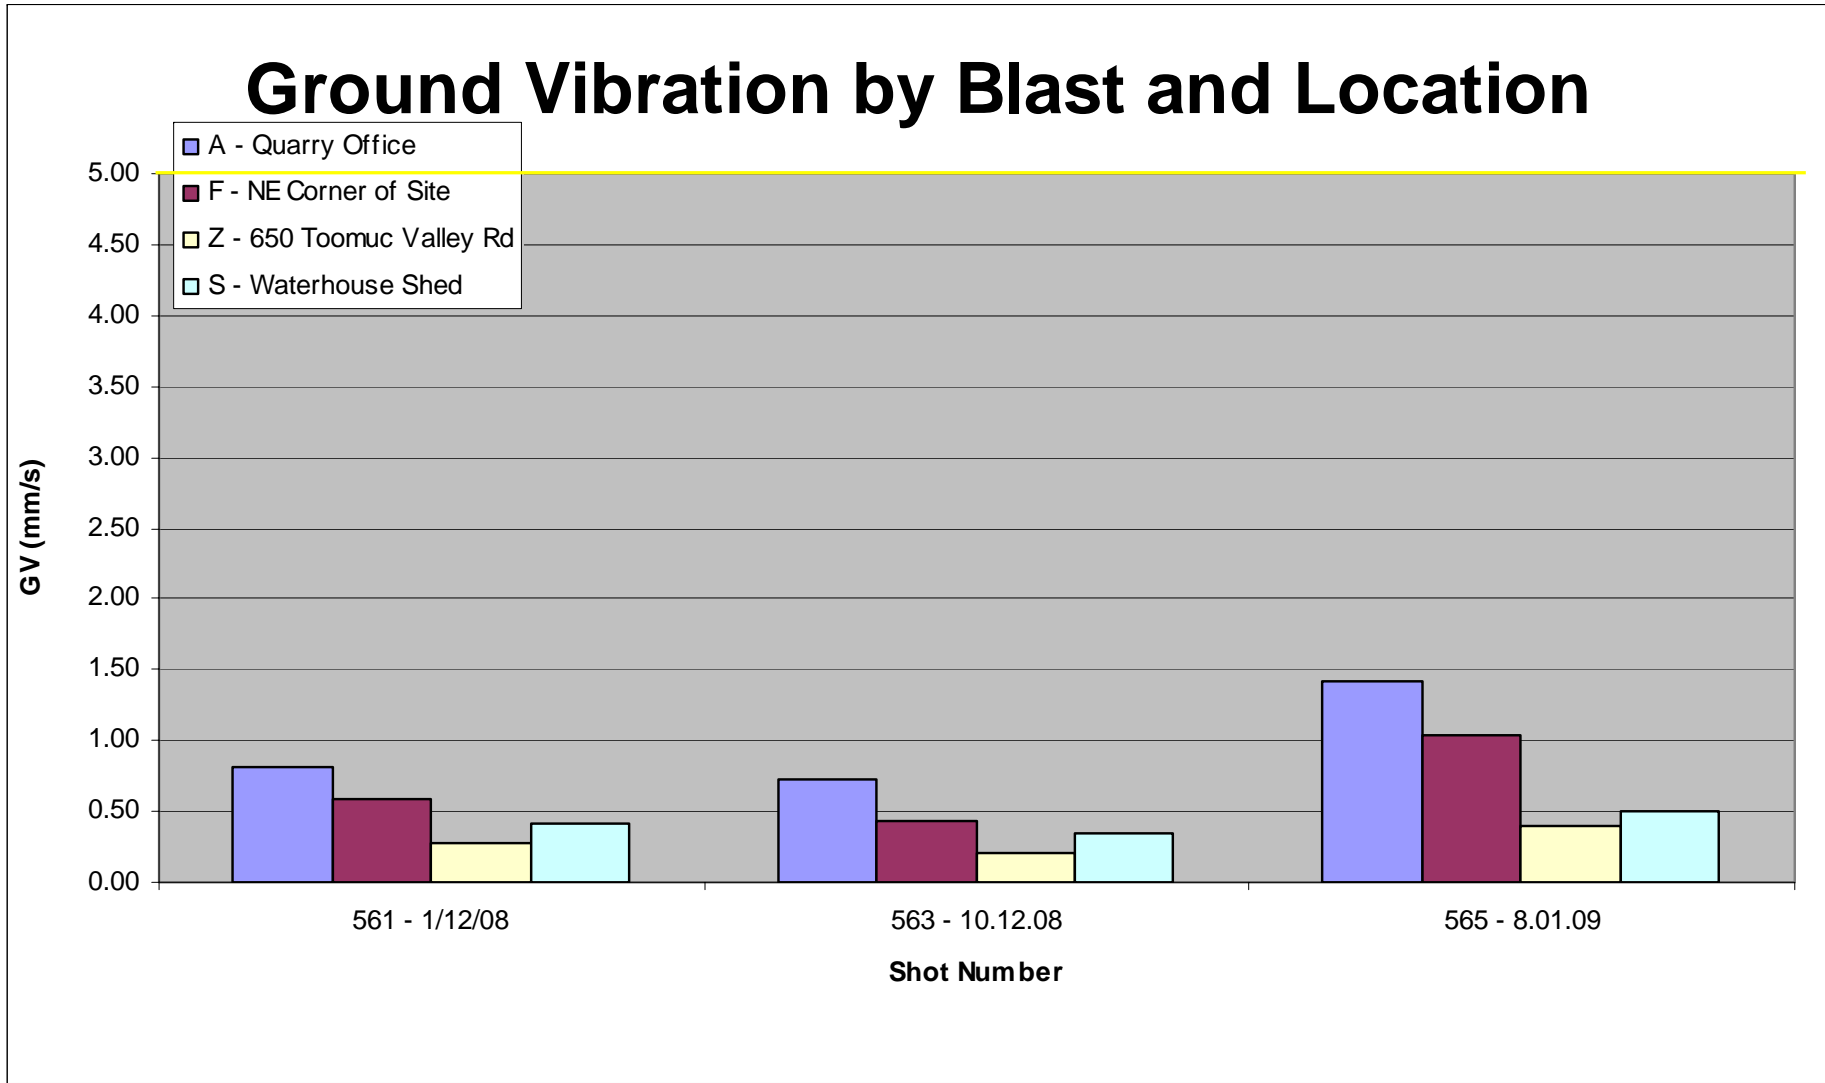
Figure 1.2: Ground Vibration by monitoring location and blast date. (Allowable Limit 5 mm/s)

Ground Vibration and Air Blast measurements conducted by specialist consultants were all within required standards as per *Mt Shamrock Quarry Environmental Management Plan Version 1: 18 January 2008*. Refer to Figures 1.2, 1.3.
