Environmental Management Report Pakenham Quarry

Compiled by
Damien Vardy

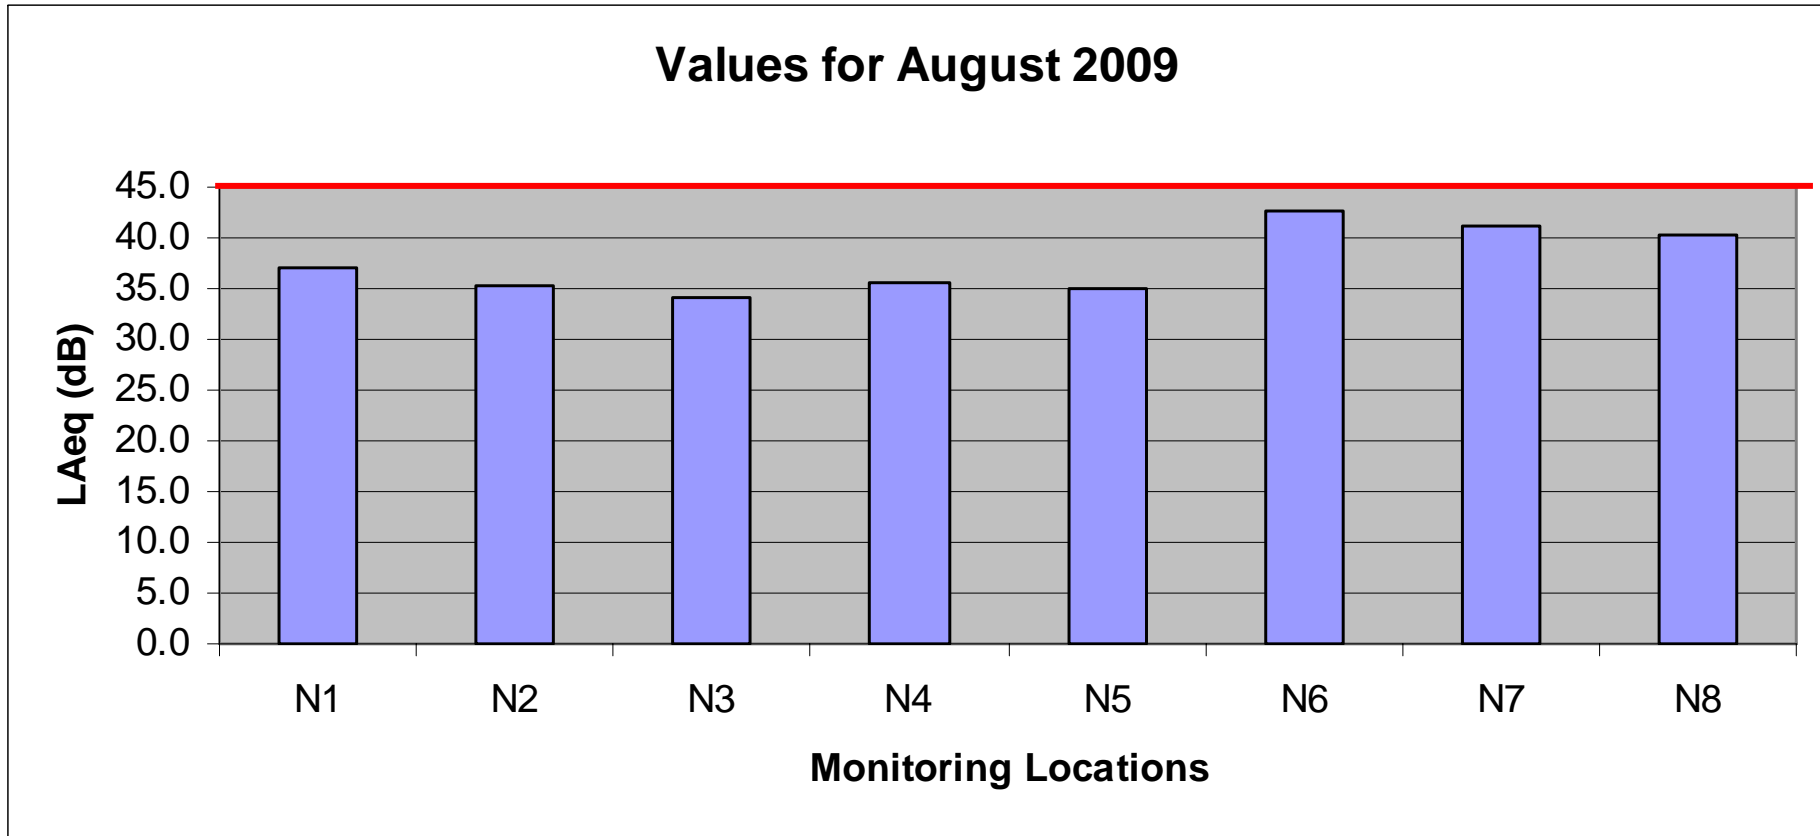
Figure1.1 Average Daily Values for Noise Monitoring of Sensitive Locations

All locations returned LAeq levels lower than the standards set out in *Mt Shamrock Quarry Environmental Management Plan Version 1: 18 January 2008*. At the date of this report there had been no complaints in relation to operating noise and therefore no noise level monitoring at a complainant's residence. Refer to Figure 1.1

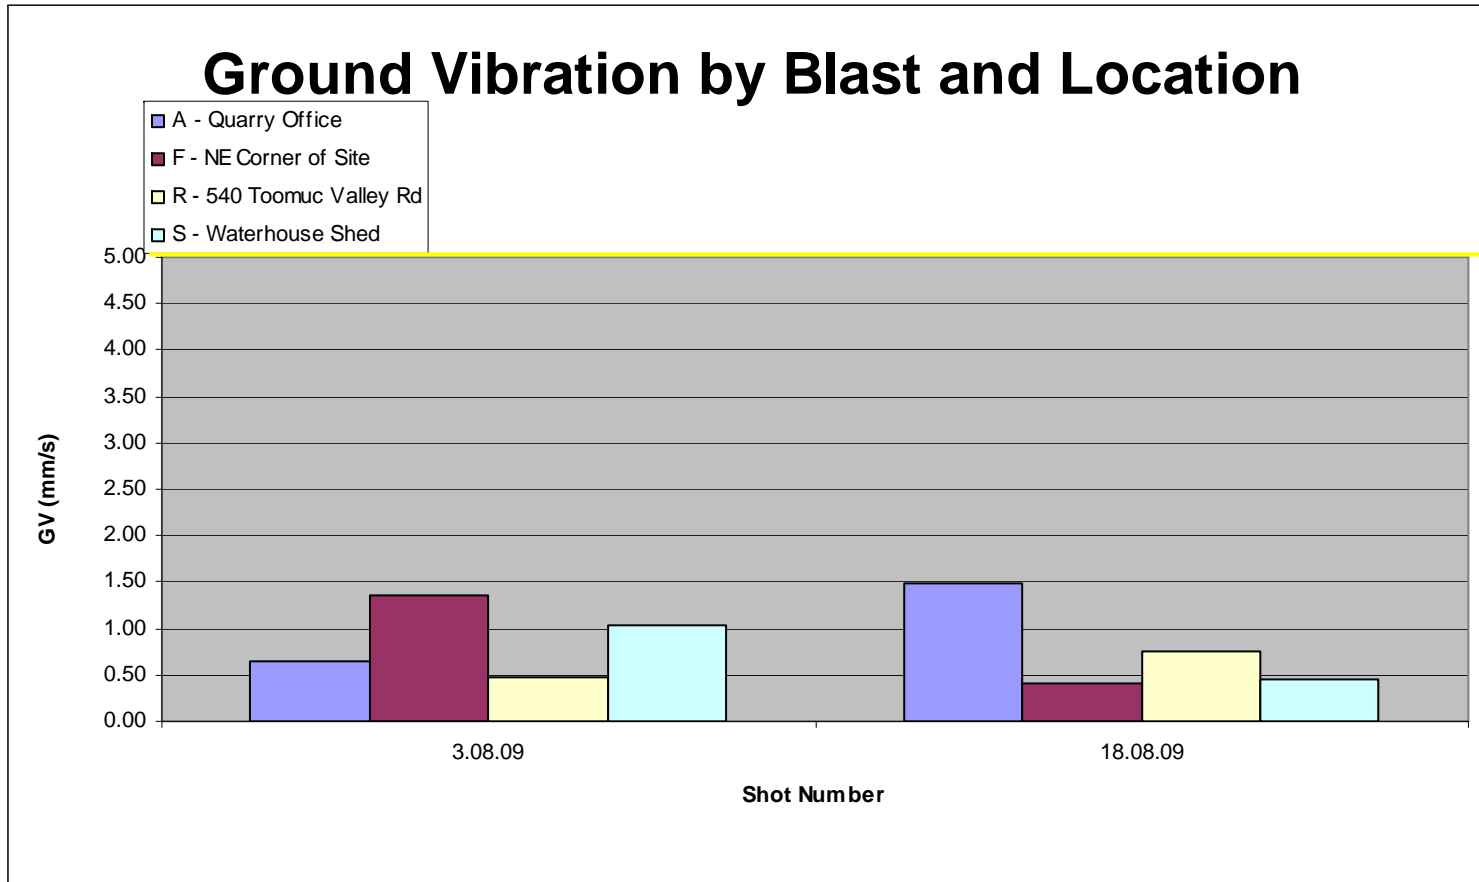
Figure 1.2: Ground Vibration by monitoring location and blast date. (Allowable Limit 5 mm/s).

Ground Vibration and Air Blast measurements conducted by specialist consultants were all within required standards as per *Mt Shamrock Quarry Environmental Management Plan Version 1: 18 January 2008*. Refer to Figures 1.2, 1.3.

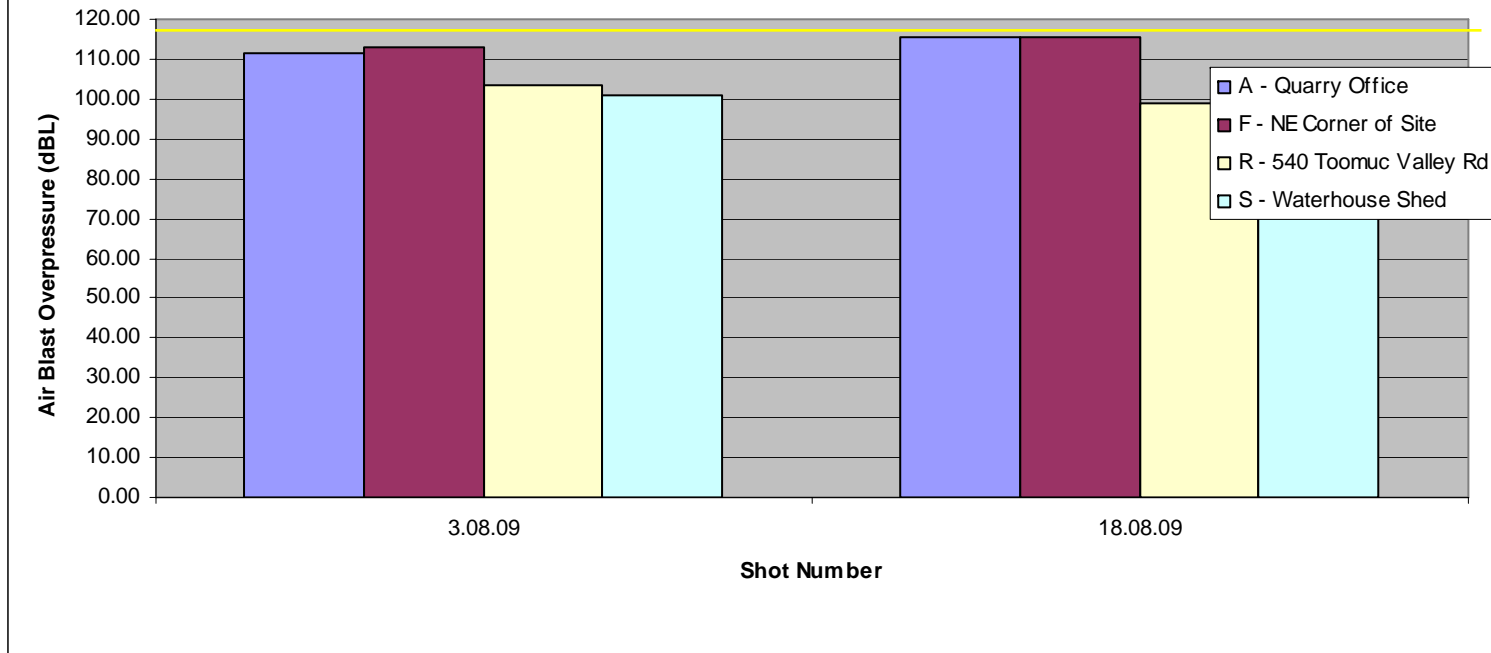
Figure 1.3: Air Blast by Monitoring Location and Blast Date (Allowable Limit 115 dBL in 95% of blasts, 120 dBL in 5% of blasts in 12month period).

Air Blast Overpressure by Blast and Location
