Mt Shamrock Quarry Environmental Management Plan 3 Monthly Progress Update

From 14 August 2008 – 14 October 2008

Prepared by Aaron Price for Mt Shamrock Quarry Environment Review Committee

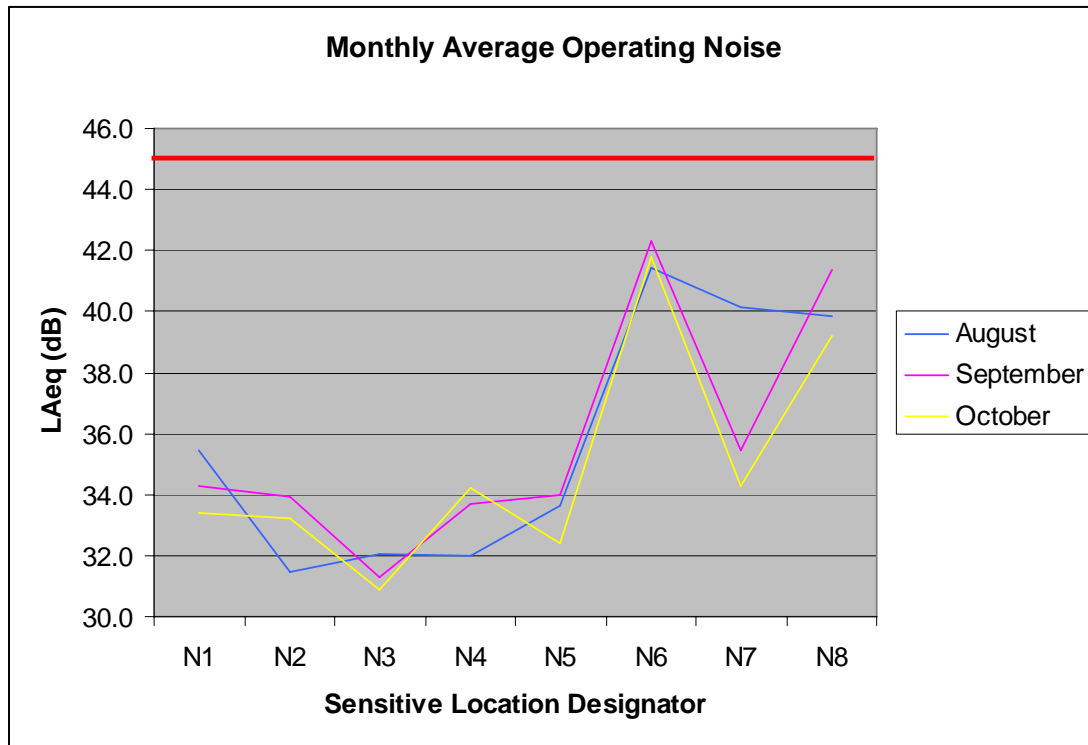
Figure 1.5: Average Monthly Noise Value by Sensitive Location
Limit is 45 dB under normal operating conditions

Daily noise monitoring at N7 ceased at the conclusion of near surface extraction. Frequency of noise monitoring at all locations is now fortnightly. Average noise levels for the preceding period are shown in Table 1.2. Significant decreases in the average values at N7 have been observed at the end of the near surface extraction phase of the extension activities. Moderate decreases have been observed in all other sensitive locations due to the cessation of near surface extraction.

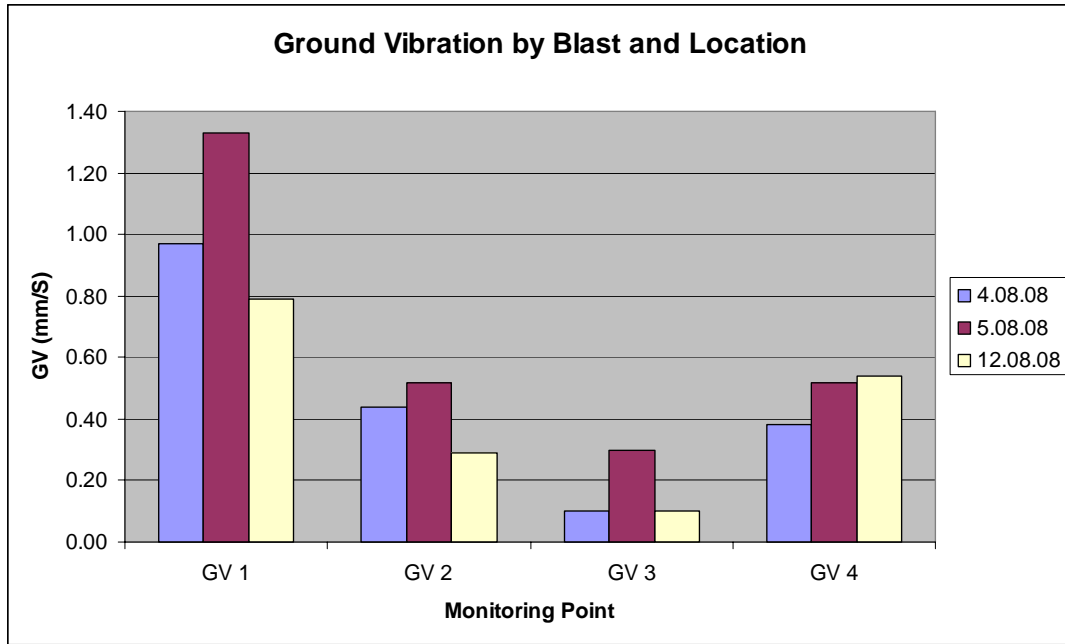
Figure 1.6: Ground Vibration by monitoring point and blast for reporting period 14 Jul to 14 Aug
Limit is 5 mm/s for 95% of blasts in a 12 month period.

All blasting operations have been carried out in accordance with the standards required. Whilst some air blast measurements obtained at AB 1 may appear to fall outside the required standards, these measurements are taken from an internal monitoring point, that at times, falls within the minimum safe distance for personnel from the area being blasted. The air blast measurements that are obtained from this monitoring point during those blasts are not indicative of the actual noise translated outside of the quarry property. Measurement instruments failed to trigger at AB1, AB2 and AB4 on the 29.09.08, this is because the activation threshold in relation to ground vibration was not met by the blast and therefore there was no results for air blast overpressure recorded. The results for ground vibration were determined as 0.01 mm/s under the activation threshold.

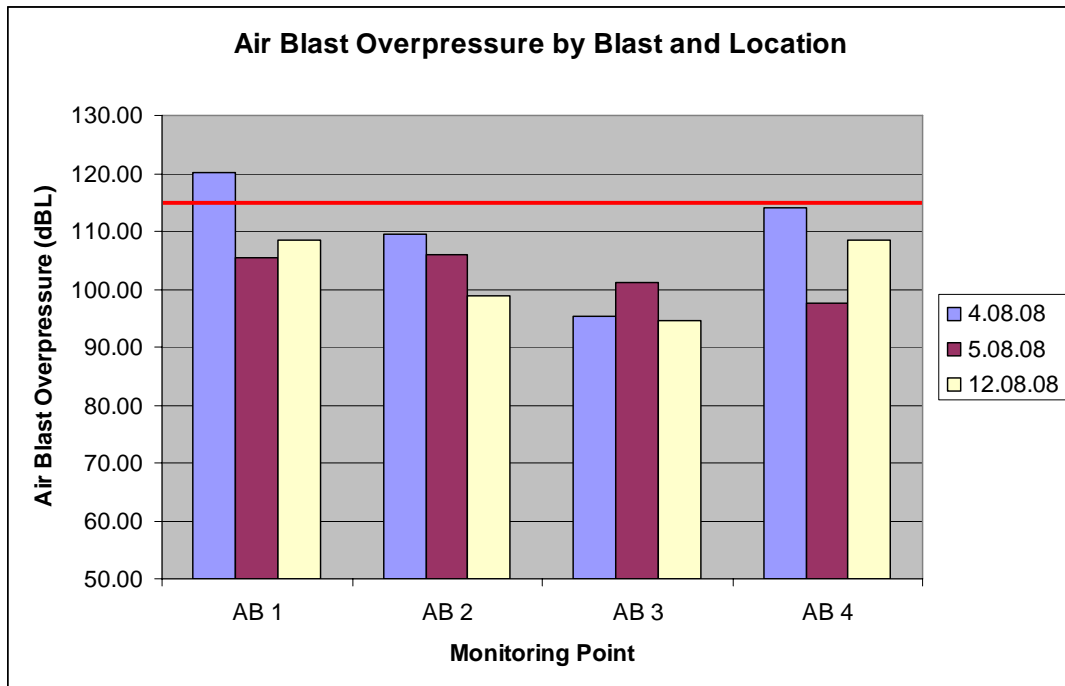
Figure 1.7: Air Blast Overpressure by monitoring point and blast for reporting period 14 Jul to 14 Aug
Limit is 115 dB(L) for 95% of blasts in a 12 month period.

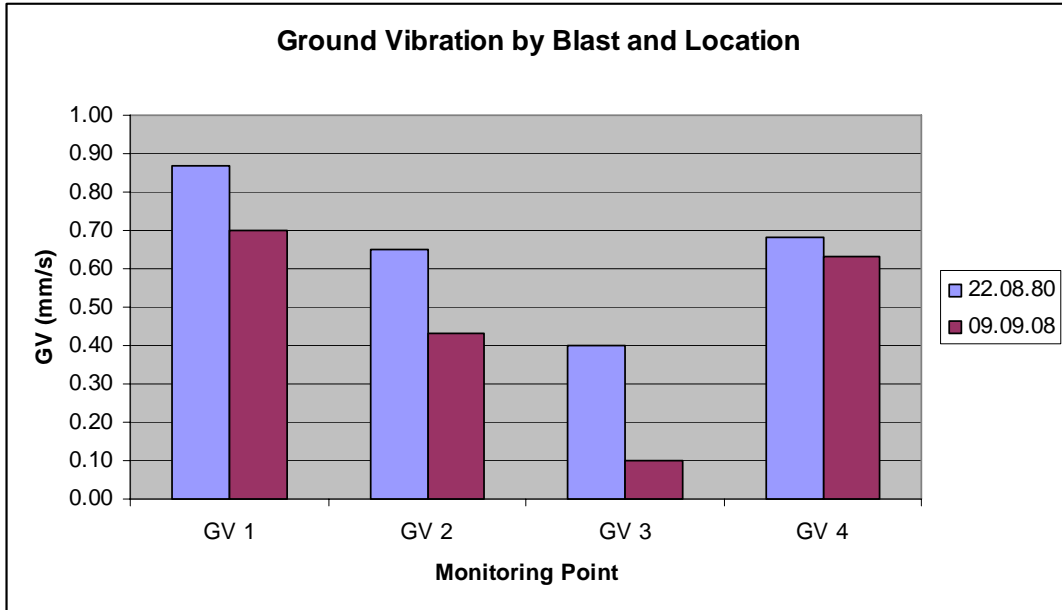
Figure 1.8: Ground Vibration by monitoring location and blast for reporting period 14 Aug – 14 Sep
Limit is 5 mm/s for 95% of blasts in a 12 month period.

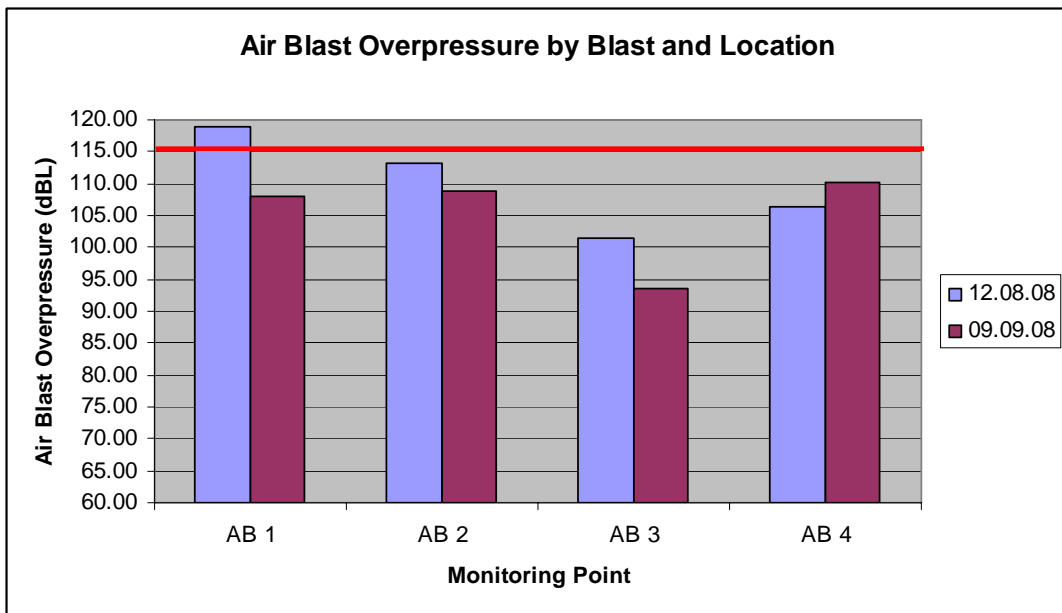
Figure 1.9: Air Blast Overpressure by monitoring location and blast for reporting period 14 Aug – 14 Sep
Limit is 115 dBL for 95% of blasts in a 12 month period.

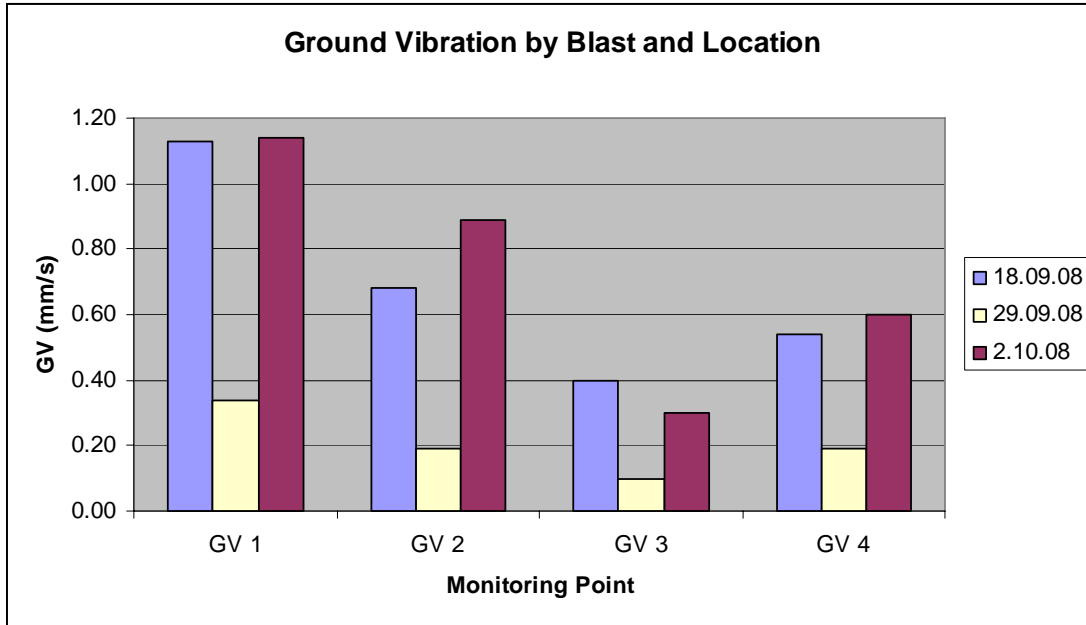
Figure 1.10: Ground Vibration by monitoring location and blast for reporting period 14 Sep – 14 Oct
Limit is 5 mm/s for 95% of blasts in 12 month period.

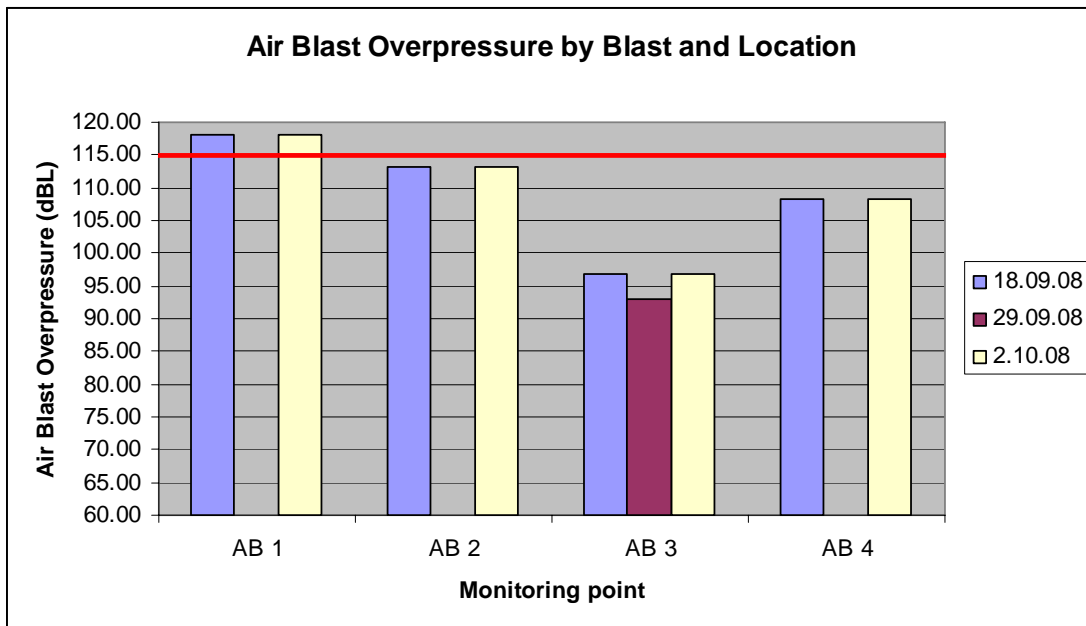
Figure 1.11: Air Blast Overpressure by monitoring location and blast for reporting period 14 Sep – 14 Oct
Limit is 115 dB for 95% of blasts in a 12 month period.

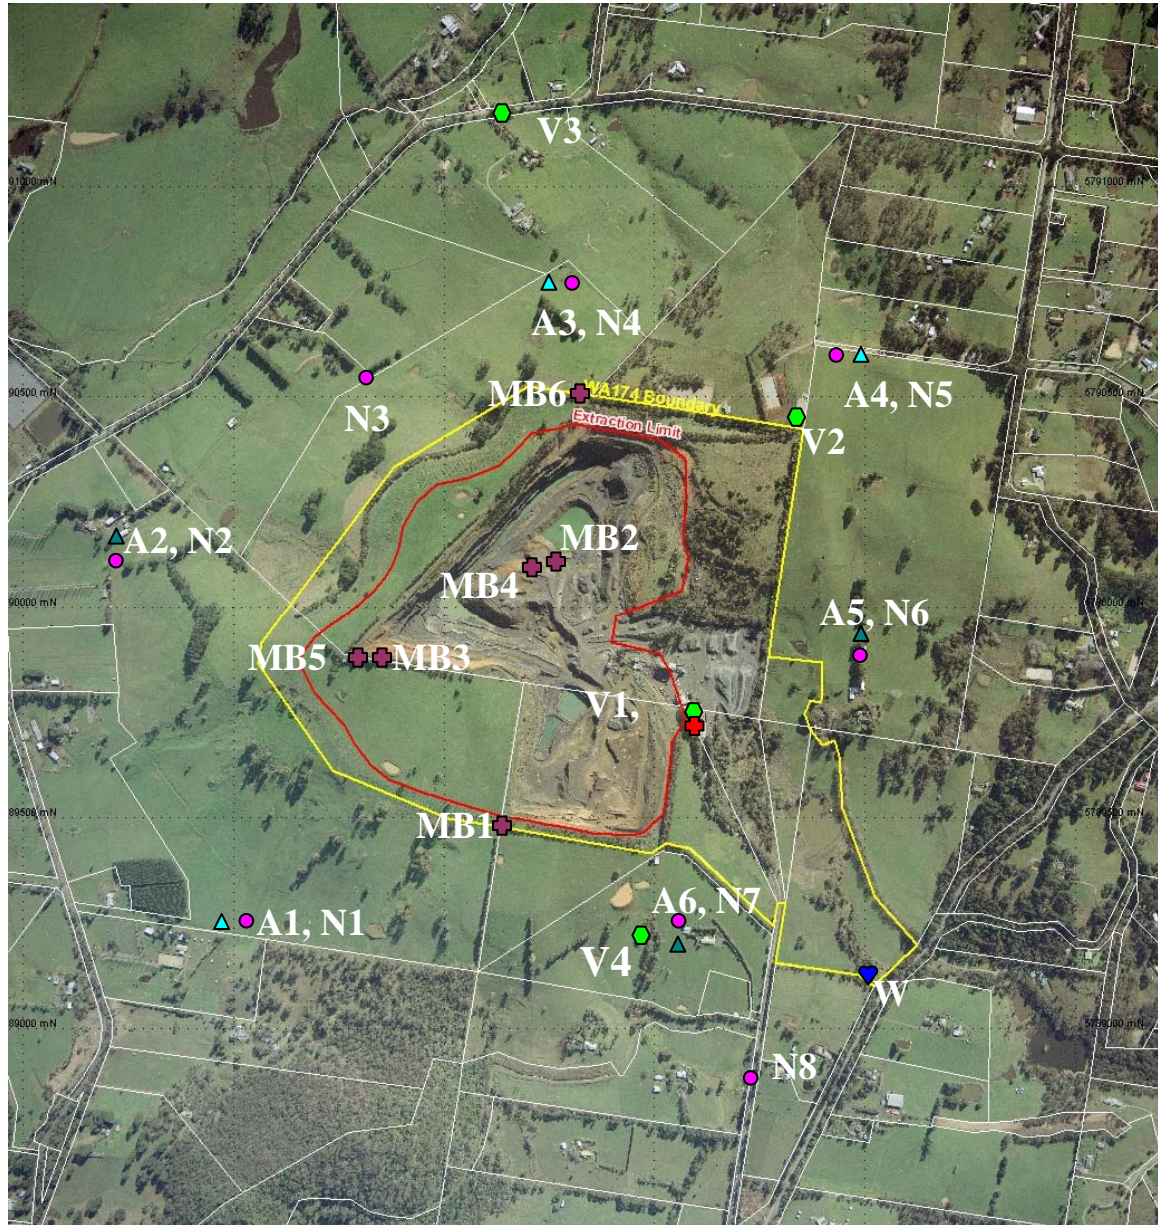
Figure 1.12 – Monitoring Locations

- ▲ A = Air monitoring location (▲ signifies high volume compliance monitoring station at A2, A5, A6)
(Note: Background PM₁₀ monitoring also at address to be determined)
- N = Noise Monitoring location
- V = Blast Vibration and Noise Overpressure location
- ◆ W = Surface Water Sampling Point
- MB = Groundwater monitoring bores
- S = Weather Station

This report details information on both monitoring results and management actions by the quarry in the preceding three months. This report will take the form of an exception report – that is where there is a deviance from the EMP, this will be highlighted and reasons for the deviance explained. A summary of quantifiable monitoring outcomes is also included. Figure 1.12 details all monitoring locations.
